OREGON CORNER RESTORATION FORM

Section 26 Township 2N Range 32E

County Umatilla Date 1-16-90

Date 1-90
 No. 90-03-A

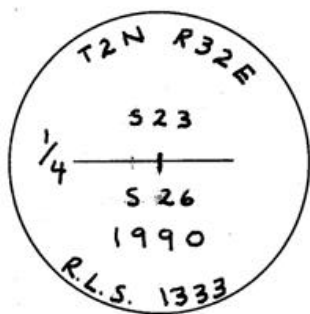
Monument Detail

Set 1"X30" G.I.P. W/flared and 2.5" brass cap 16" below ground surface.

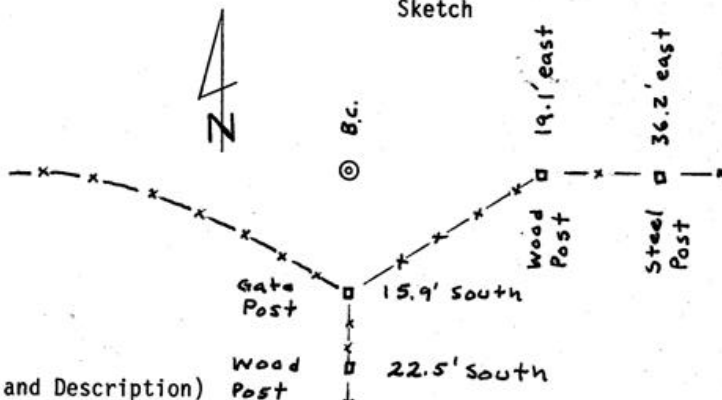
Sketch

No monuments and accessories were found. The only remaining evidence is a fence to the east, south and west. The fence to the west has a bow in it 300 to 400 ft. west from the corner.

1. Good wood fence post bears east 19.1 ft.
2. Steel fence post bears east 36.2 ft.
3. Good wood gate post bears south 15.9 ft.
4. Good wood fence post bears south 22.5 ft.

Corner in bottom of drainage running north and south Compass Declination _____
 Firm/Agency Don Staebler
 Engineer- Surveyor _____
