**OREGON CORNER RESTORATION FORM**

Section 14 Township 3N Range 27E  
 County Umatilla Date 06-29-08

Corner Designation: 3N27E24

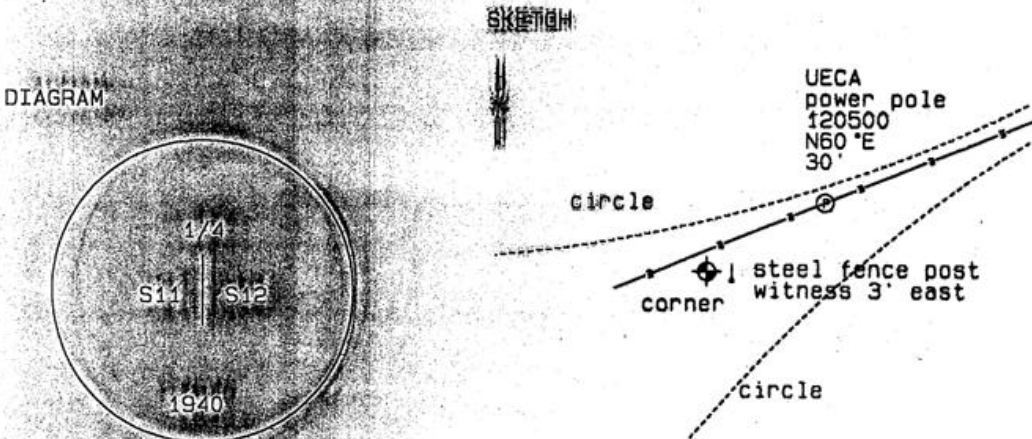
Monument and Accessories Found: (Location and source)  
 Found standard GLO brass cap on an iron pipe between irrigation circle roads. Pipe is bent 14" down. Brass location at apparent center of lower part of pipe.
