CERTIFIED RECORD OF LAND CORNER MONUMENTATION

T3N R33E

1/4 $\frac{S2}{S11}$ WC

Section	HWY11 - HELIX		
	Highway	OR 335, HAVANA-HELIX HWY.		
	County	Umatilla	Scale	NTS
	Purpose	Corner Restoration	Date	July 13, 2017
	File

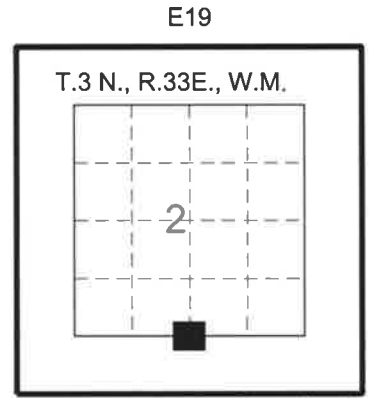
Found railroad spike in center of south bound lane of the Helix Hwy., (OR 335), spike is bent and top half laying horizontal and flattened to surface of pavement, top has cross and punchmark. I removed the spike from road and found that bottom half was vertical and the hole left after removing spike was also vertical, not deformed, and matched positions of found accessories.

- A found 2 3/8 ins. diam. brass cap, down 1 ins. in a small ditch near face of railroad tie post, bears at record (N 45° 50' E, 43.01'), marked as shown above at right:
 - A found 1 1/2 ins. diam. red plastic cap, down 3 ins., 1 ft. NE'ly of power pole, marked: ORPLS43406 WAPLS44338, bears at record (S24° 10'W, 41.39').
 - A found 5/8 ins. diam. iron rod, no cap, at ground level, 0.8 ft. SE'ly of power pole, bears at record (N23° 40'W, 46.39').
- NOTE: I did not excavate nor recover the magnet in SE quadrant.

Set a 3 1/4 ins. diam. alum. cap on a 5/8 ins. diam. by 30 ins. long iron rod (rebar), driven 23 inches in the ground, placed inside a 10 ins. diam. cast iron monument box. Cap is 3 ins. below surface of road. Marked as shown:
