OREGON CORNER RESTORATION FORM

Section: 10, 11, 14, 15 Township: 3N Range: 33E
County: Umatilla Date: 2/18/2011

Corner Designation: 3N33J17 (Amended 3/28/2012)

Section corner common to Sections 10, 11, 14, 15, T3NR33E.

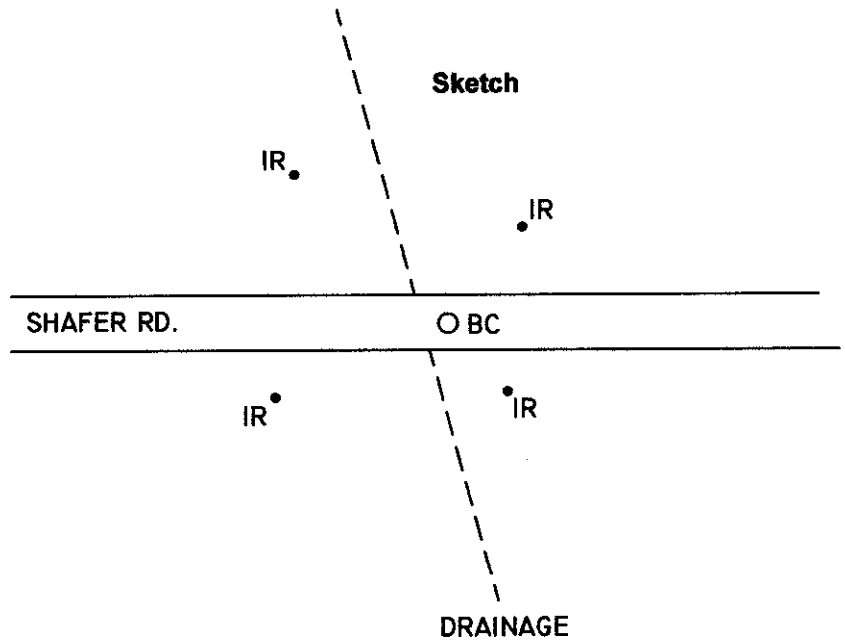
Sketch

A 2 1/2" brass cap, stamped as shown below, 11" below the surface.

- A 5/8" x 30" iron rebar w/RPC #43406 lies N 46° 50' W, 55.51'.
- A 5/8" x 30" iron rebar w/RPC #43406 lies N 37° 50' E, 31.53', 17" deep.
- A 5/8" x 30" iron rebar w/RPC #43406 lies S 41° E, 23.38'.
- A 5/8" x 30" iron rebar w/RPC #43406 lies S 67° 10' W, 48.01'.
