OREGON CORNER RESTORATION FORM

Corner Designation: 3N33J19

Corner common to section 11 and 14 T3NR33E.

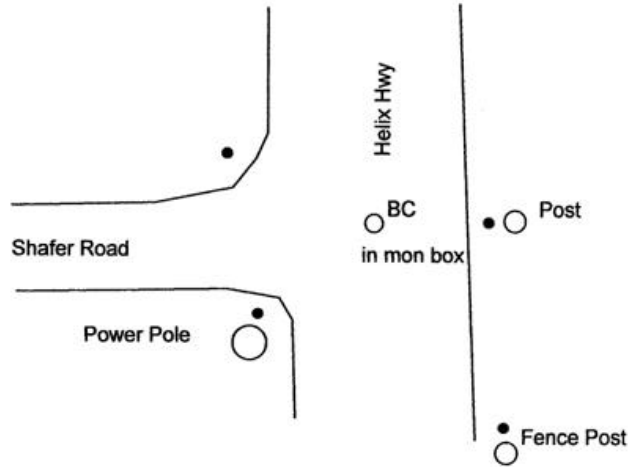
Sketch

A 2 1/2" brass capped monument stamped as shown below, in a monument box.
