OREGON CORNER RESTORATION FORM

Section: 12, 13 Township: 3N Range: 33E
 County: Umatilla Date: 3/8/2012

Corner Designation: 3N33J23

Quarter corner common to Sections 12, 13, T3NR33E.

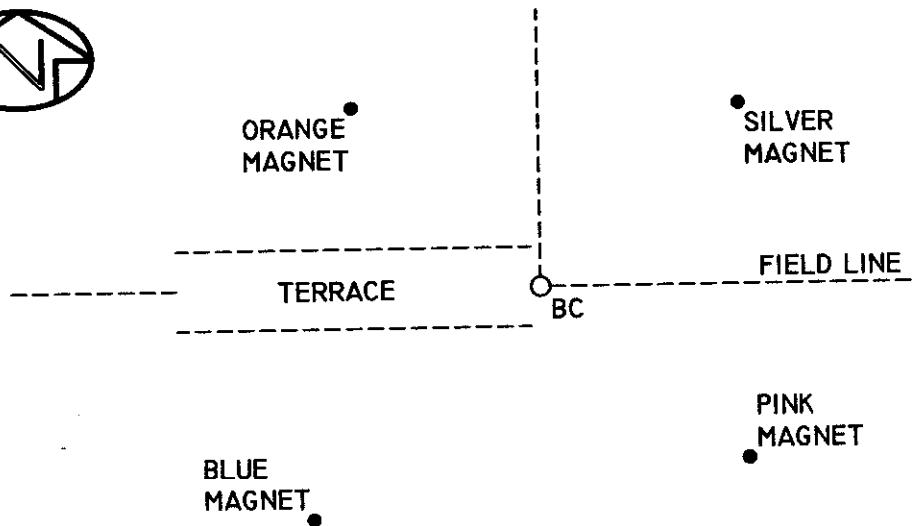
Sketch

None.

A 1 1/8" x 30" galvanized iron pipe with 2 1/2" brass cap, stamped as shown above, 1.5' below the surface. The corner location was reestablished by holding the East-West line between neighboring corners and then holding the Easting of a very old steel fence post at the intersection of field lines from the North and East.

- "Deep One" magnets by Berntsen.
- An orange magnet lies N 45° 30' W, 26.92', 1.7' deep.
- A silver magnet lies N 49° 10' E, 28.03', 1.7' deep.
- A pink magnet lies S 48° 45' E, 29.84', 1.8' deep.
- A blue magnet lies S 45° 40' W, 33.79', 1.7' deep.
