OREGON CORNER RESTORATION FORM

Section: 8, 17
County: Umatilla

Corner Designation: 3N33J07

Quarter corner common to Sections 8, 17, T3NR33E.

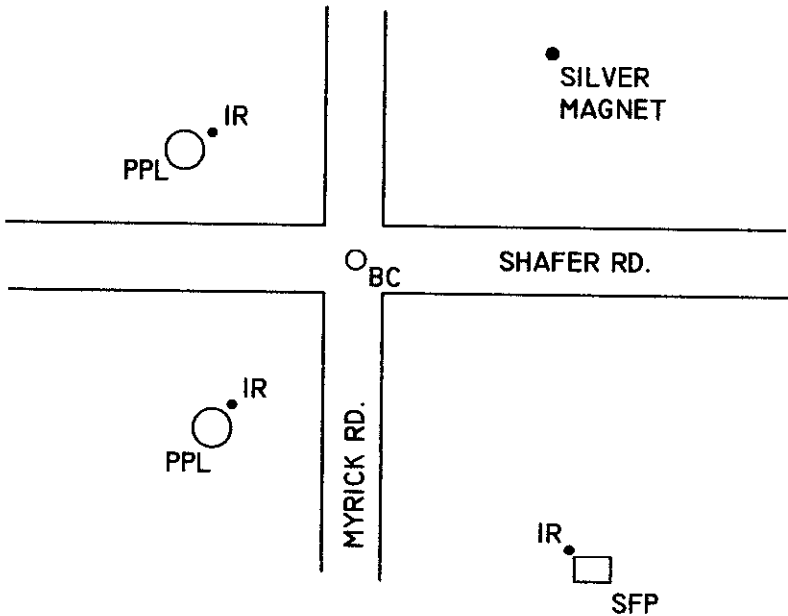
Sketch

None.

The corner is located at the center of the intersection of Shafer Rd. and Myrick Rd.

A 1 1/8" x 30" galvanized iron pipe with a 2 1/2" brass cap, stamped as shown above, 1' below the surface. Holding Umatilla County Road Notes as the best evidence, reestablished the corner in the center of the intersection of Shafer Rd. and Myrick Rd.

- "Deep One" magnet by Berntsen.
- A 5/8" x 30" iron rebar w/RPC #43406 lies N 48° 30' W, 30.10', at a power pole.
- A silver magnet lies N 42° 40' E, 39.24', 1.5' deep.
- A 5/8" x 30" iron rebar w/RPC #43406 lies S 36° 45' E, 42.57', at a steel fence post.
- A 5/8" x 30" iron rebar w/RPC #43406 lies S 40° 15' W, 34.30', at a power pole.
