OREGON CORNER RESTORATION FORM

Section: 17, 18 Township: 3N Range: 33E
County: Umatilla Date: 5/25/2011

Corner Designation: 3N33L05

Quarter corner common to Sections 17, 18, T3NR33E.

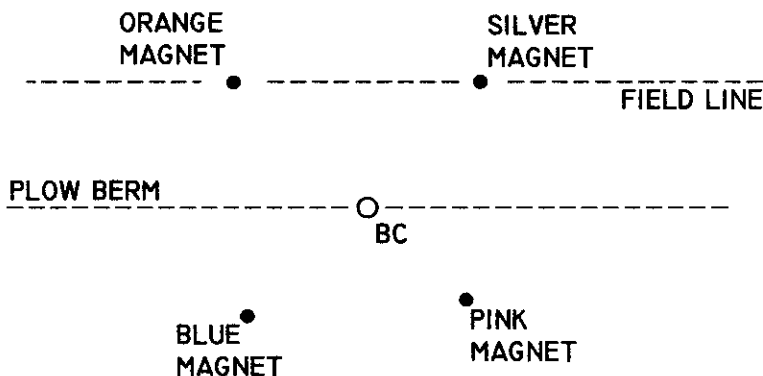
Sketch

None.

A 1 1/8" x 30" galvanized iron pipe with a 2 1/2" brass cap, stamped as shown above, 1.3' below the surface. Corner location was reestablished by a combination of holding the North-South line between found corners and holding a long established East-West plow berm.

- "Deep One" magnets by Berntsen.
- An orange magnet lies N 47° W, 20.25', 1.3' deep.
- A silver magnet lies N 42° E, 20.27', 1.4' deep.
- A pink magnet lies S 47° E, 19.83', 1.3' deep.
- A blue magnet lies S 48° 30' W, 21.05', 1.3' deep.
