**OREGON CORNER RESTORATION FORM**

Corner Designation: 3N33N19

Quarter corner common to Sections 14, 23, T3NR33E.

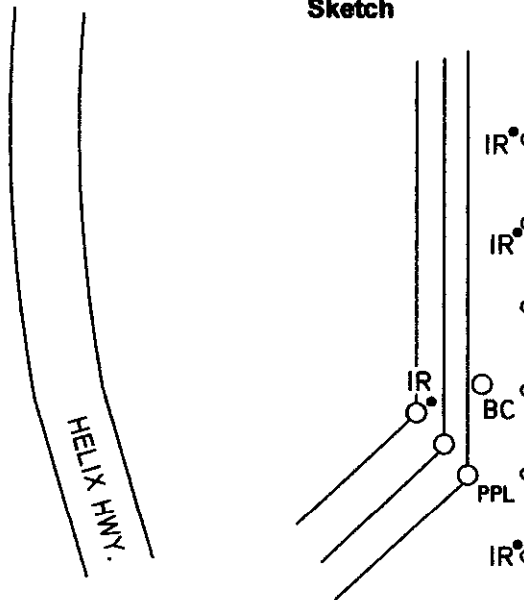
Sketch

None.

A 1 1/8" x 30" galvanized iron pipe with 2 1/2" brass cap, stamped as shown above. The corner location was reestablished by single proportionate method between neighboring corners to the East and West, approximately 15' West of existing North-South fence.

- A 5/8" x 30" iron rebar w/RPC #43406 lies N 6° 20' E, 132.50', at a steel fence post.
- A 5/8" x 30" iron rebar w/RPC #43406 lies N 12° E, 81.85', at a steel fence post.
- A 5/8" x 30" iron rebar w/RPC #43406 lies S 15° 35' E, 67.88', at a steel fence post.
- A 5/8" x 30" iron rebar w/RPC #43406 lies S 71° 55' W, 27.37', at a power pole.
