OREGON CORNER RESTORATION FORM

Corner Designation: 3N33N07

Quarter corner common to Sections 17, 20, T3NR33E.

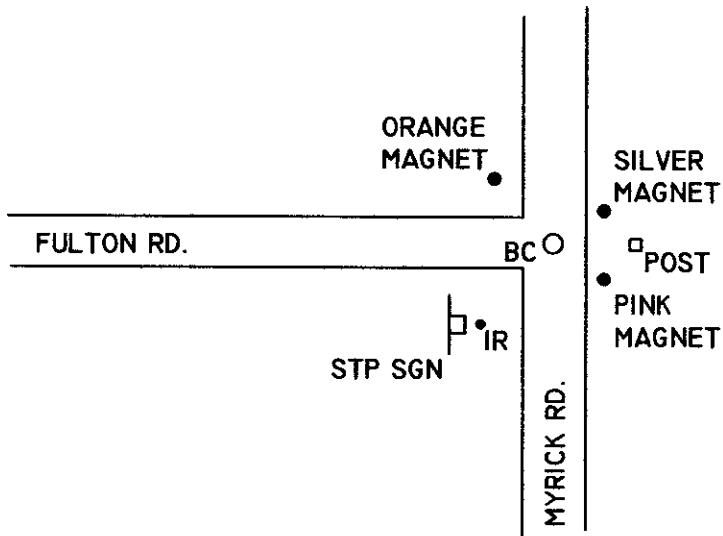
Sketch

A 1 1/8" x 30" galvanized iron pipe with a 2 1/2" brass cap, stamped as shown above, 1.0' below the surface. The corner location was reestablished by holding the centerline intersect of Fulton Rd. and Myrick Rd, per Umatilla County Road Notes, as the best evidence of the original corner position.

- "Deep One" magnets by Bermtsen.
- An orange magnet lies N 44° 20' W, 45.21', 1.6' deep.
- A silver magnet lies N 45° 30' E, 29.65', 1.3' deep.
- A pink magnet lies S 52° E, 27.38', 1.1' deep.
- A 5/8" x 30" iron rebar w/RPC #43406 lies S 35° 20' W, 45.45', at a stop sign.
