OREGON CORNER RESTORATION FORM

Section 2 Township 4N Range 33E
 County Umatilla Date: January 7, 2000

Corner Designation: 4N33C17

Quarter corner for Sections 2 and 3,
 T4N, R33E, W.M.

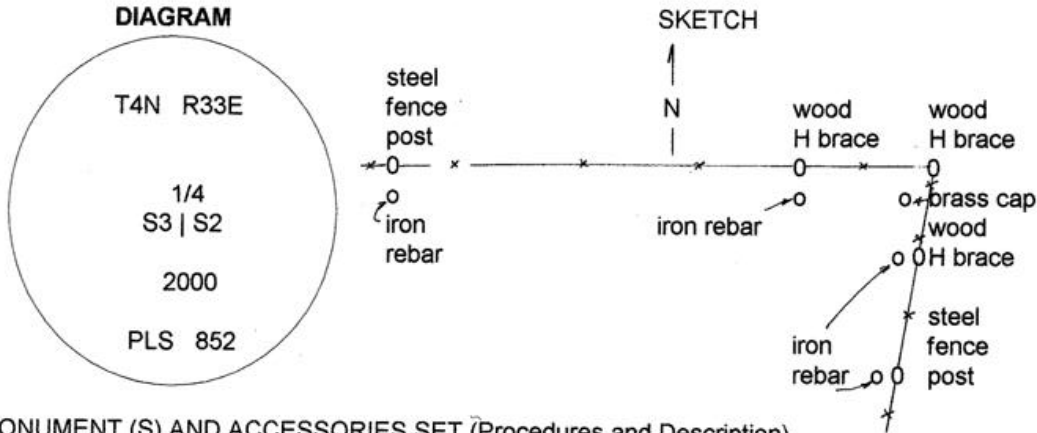
Monument and Accessories found: (condition and source)
 Found intersection of fence from south and fence from west.

MONUMENT (S) AND ACCESSORIES SET (Procedures and Description)
 At a point just southwest of the fence intersection, I set a 1.25" x 30" galvanized iron pipe with a 2.25" brass cap stamped as shown in the diagram above, flush with ground surface.
