CERTIFIED RECORD OF LAND CORNER MONUMENTATION

| RIGHT OF WAY ENGINEERING SKETCH MAP | Section | HWY.11 - HELIX | | |
| | Highway | OR 335, HAVANA - HELIX HWY. | | |
| | Purpose | Corner Restoration | Date | July 14, 2017 |

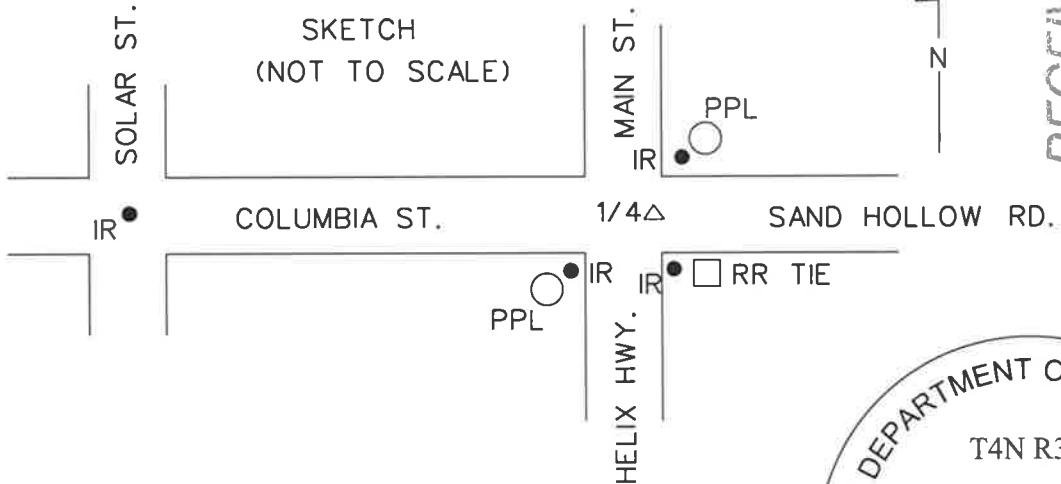
Found a railroad spike, down 2 ins. under asphalt pavement, marked with punch mark and scored line with 2 above line and 11 below line and 1/4 stamped to right side. At north edge of head of spike there are illegible markings and a large score mark, possibly from snow plowing.

I found the above said accessories intact and bearing at record.

Set a 3 1/4 ins. diam. alum. cap on a 5/8 ins. diam. by 30 ins. long iron rod (rebar), driven 26 inches in the ground, and placed inside a 10 inch diameter cast iron monument box. Top of cap is 6 ins. below surface of road. Marked as shown:
