OREGON CORNER RESTORATION FORM

Corner Designation: 3N33A13

Section corner common to Sections 3,4, T3NR33E; 33, 34, T4NR33E.

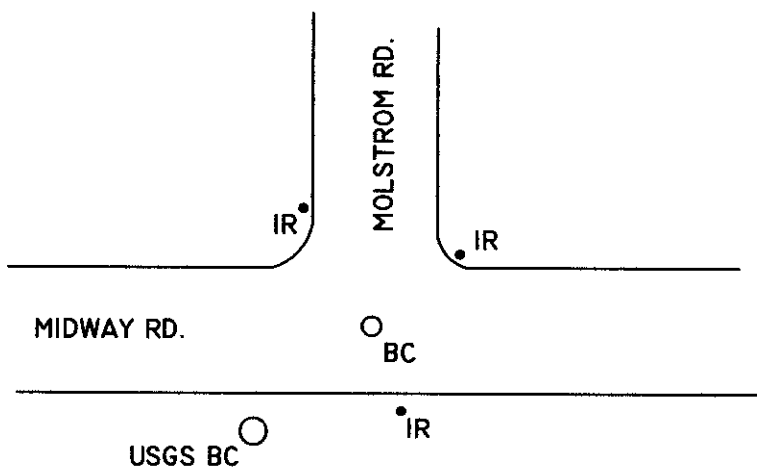
Sketch

A 2 1/2" brass cap, stamped as shown below, 1.0' below the surface.
A 5/8" iron rebar w/YPC PLS #2360 lies N 47° 54' E, 41.21'.
A 5/8" iron rebar w/YPC PLS #2360 lies S 6° 26' E, 20.89'.
A 3 1/2" USGS brass cap BM lies S 48° 33' W, 35.87'.

A 5/8" x 30" iron rebar w/RPC #43406LS lies N 12° 30' W, 58.93'.
