OREGON CORNER RESTORATION FORM

Section: 2, 3, 34, 35 Township: 3N, 4N Range: 33E
County: Umatilla Date: 3/25/2011

Corner Designation: 3N33A17 (Amended 4/3/2012)

Section corner common to Sections 2, 3, T3NR33E; 34, 35, T4NR33E.

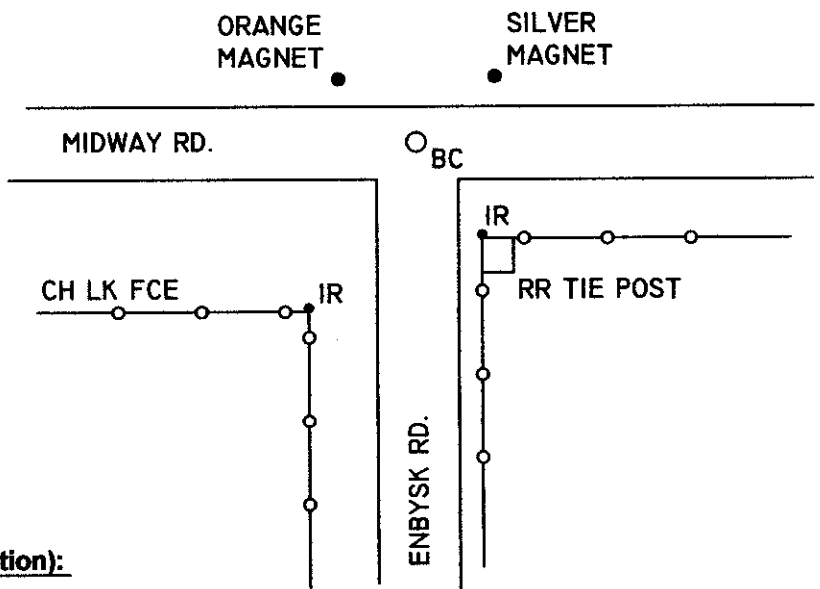
Sketch

An unrecorded 2 1/2" brass cap, stamped as shown below, 8" below the surface.
