OREGON CORNER RESTORATION FORM

Section 9 Township 1S Range 32E
 County Umatilla Date: April 5, 2000

Corner Designation: 1S32G13

1/4 corner to sections 9 and 10, T1S, R32E W.M.

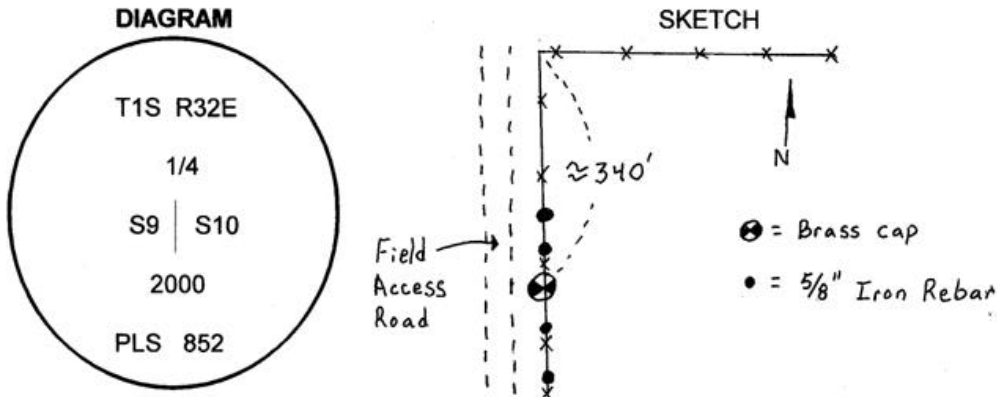
Monument and Accessories found: (condition and source)
 None.

Set a 1 1/4" x 30" Galvanized Iron Pipe with a 2 1/2" brass cap stamped as shown in the diagram above at the intersection of the line between the NE and SE section corners of section with the line from the West quarter corner of section 9 projected through the center quarter as identified from the plat of the Royer Addition to the City of Pilot Rock. The position falls one foot west of a North - South fence line.
