RECORD OF SURVEY

TOWNSHIP 3 NORTH, RANGE 29 EAST, WILLAMETTE MERIDIAN, UMATILLA COUNTY, OREGON.

CORRECTED RECORD OF SURVEY

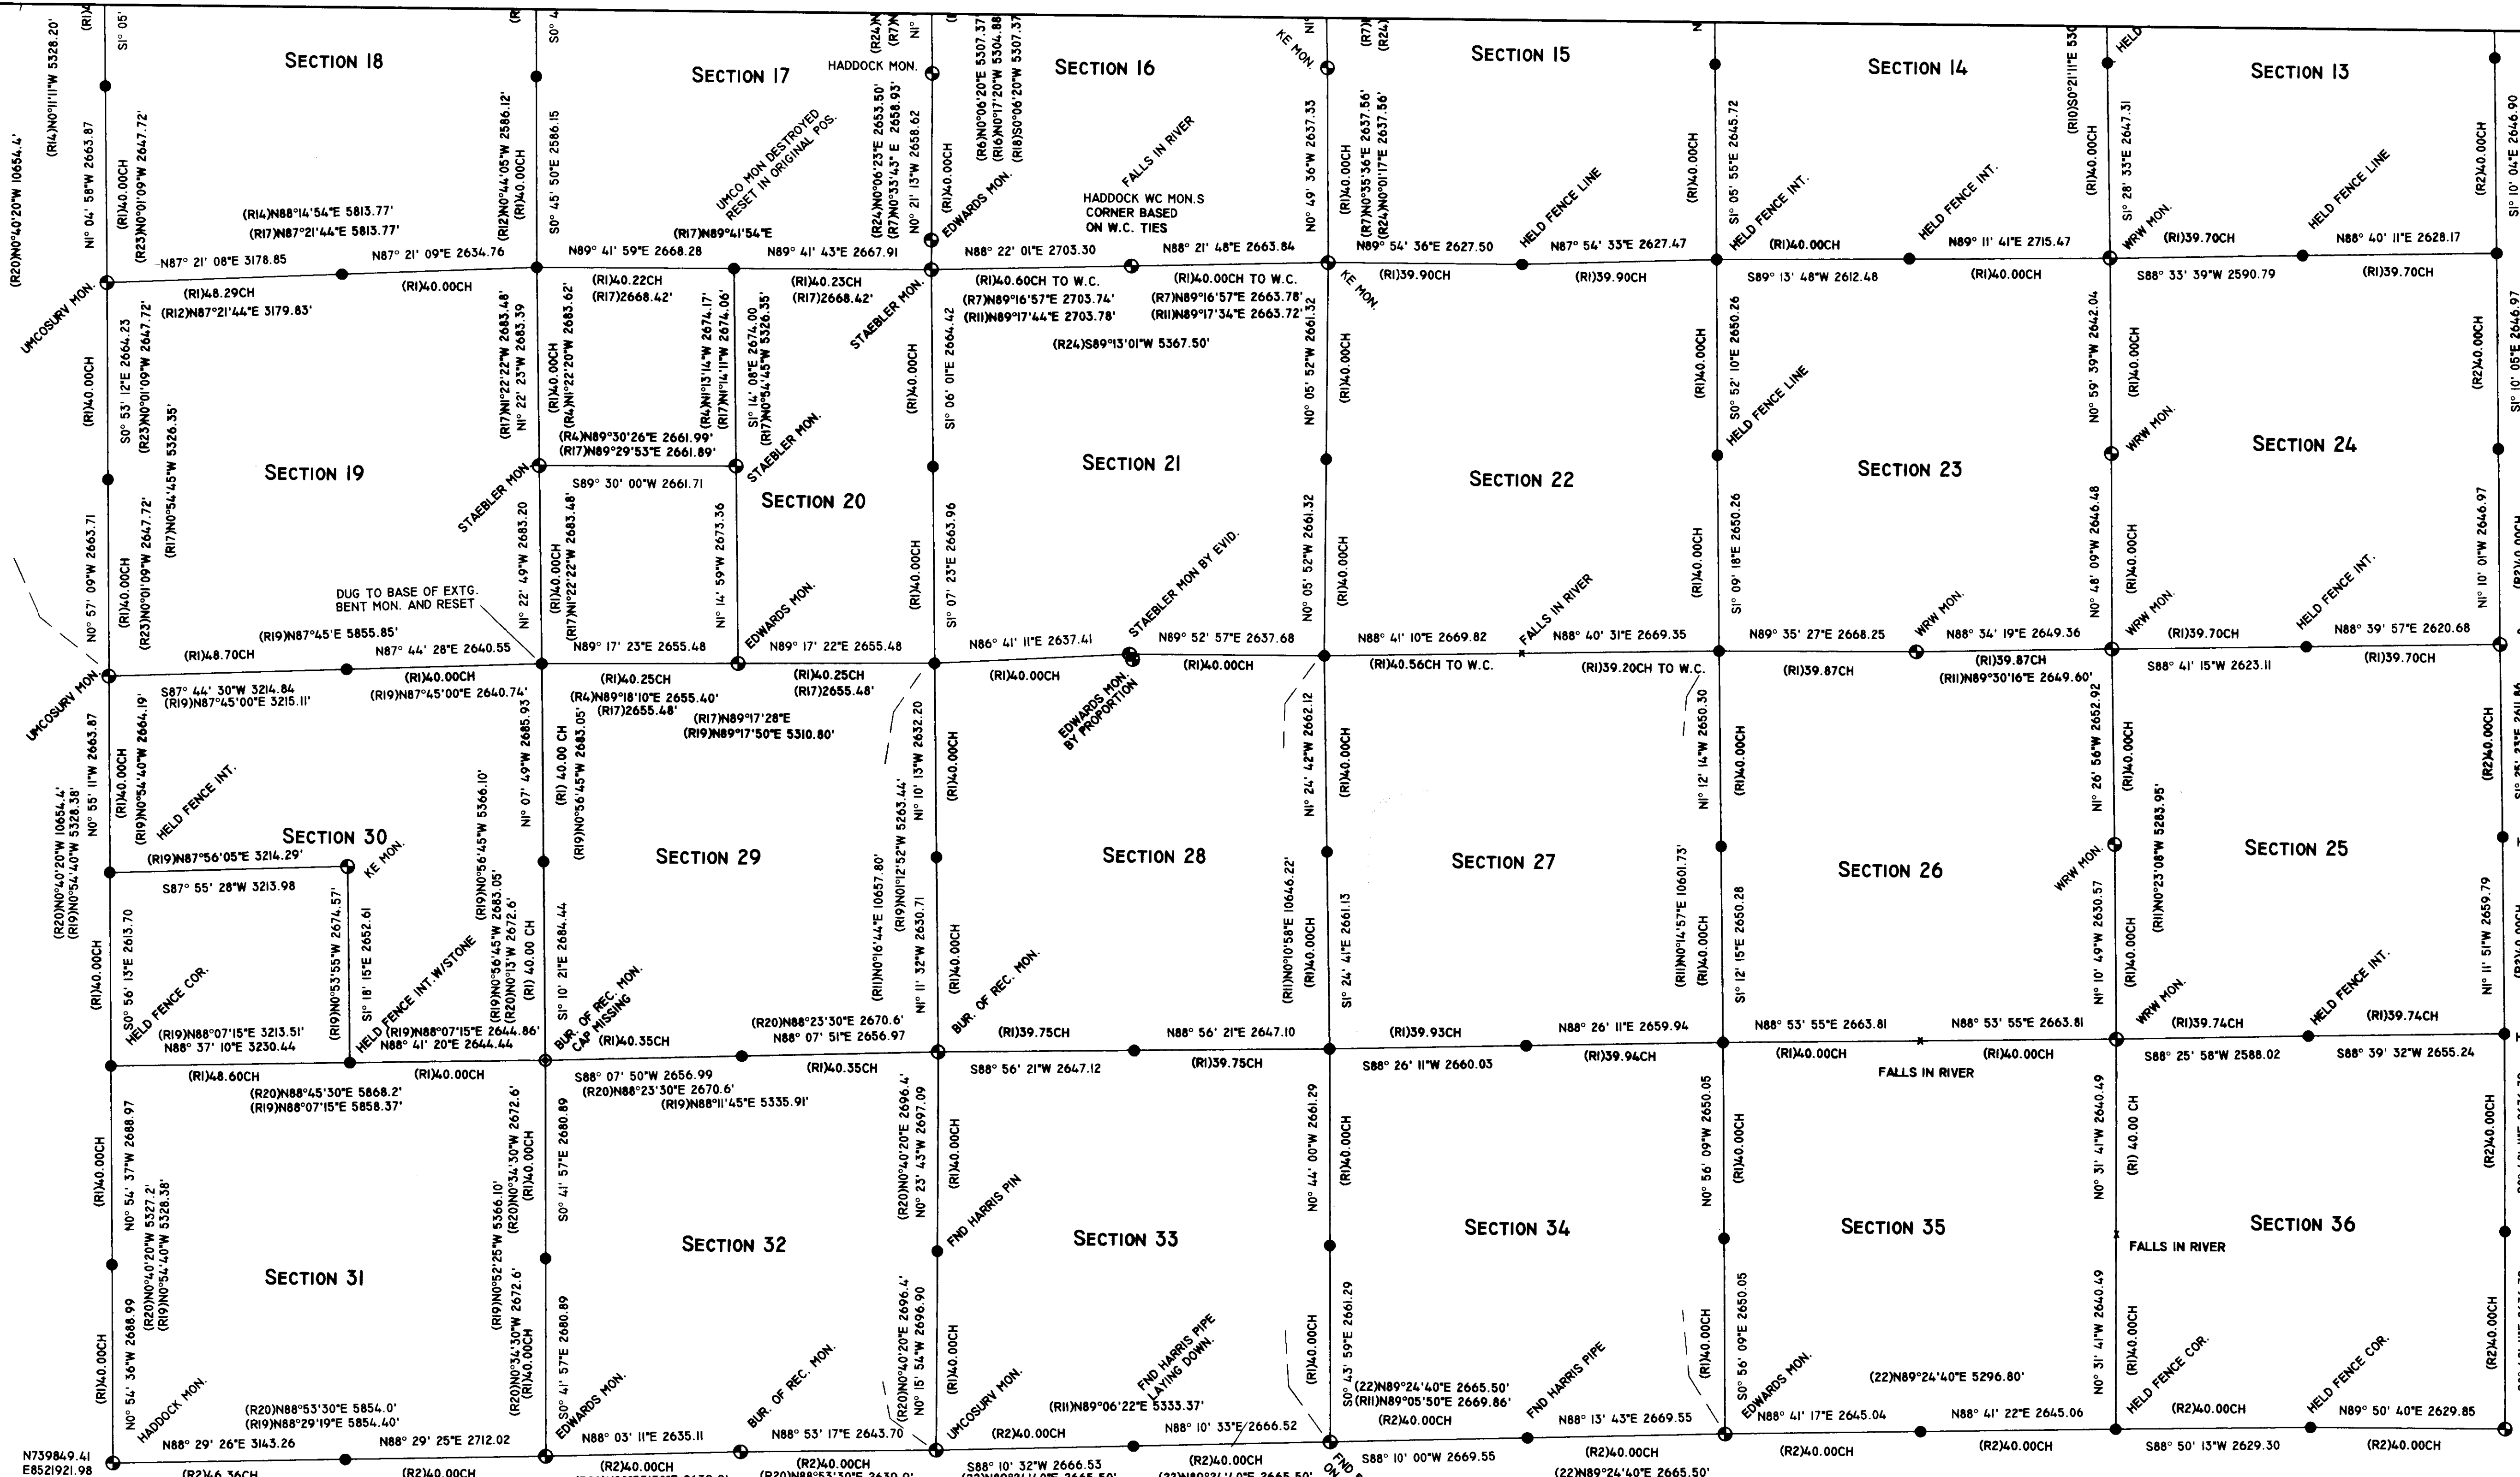
THIS SURVEY WAS PERFORMED UNDER CONTRACT TO THE UMATILLA COUNTY SURVEYOR TO TIE, MAINTAIN AND MONUMENT CORNERS IN TOWNSHIP 3 NORTH, RANGE 29 EAST, WILLAMETTE MERIDIAN, AND REPORT NAD 83/91 OREGON NORTH STATE PLANE COORDINATES AS DIRECTED UNDER ORS 93. LOST CORNER POSITIONS WERE RE-ESTABLISHED AS DIRECTED UNDER THE 1973 BLM MANUAL OF SURVEYING INSTRUCTIONS...

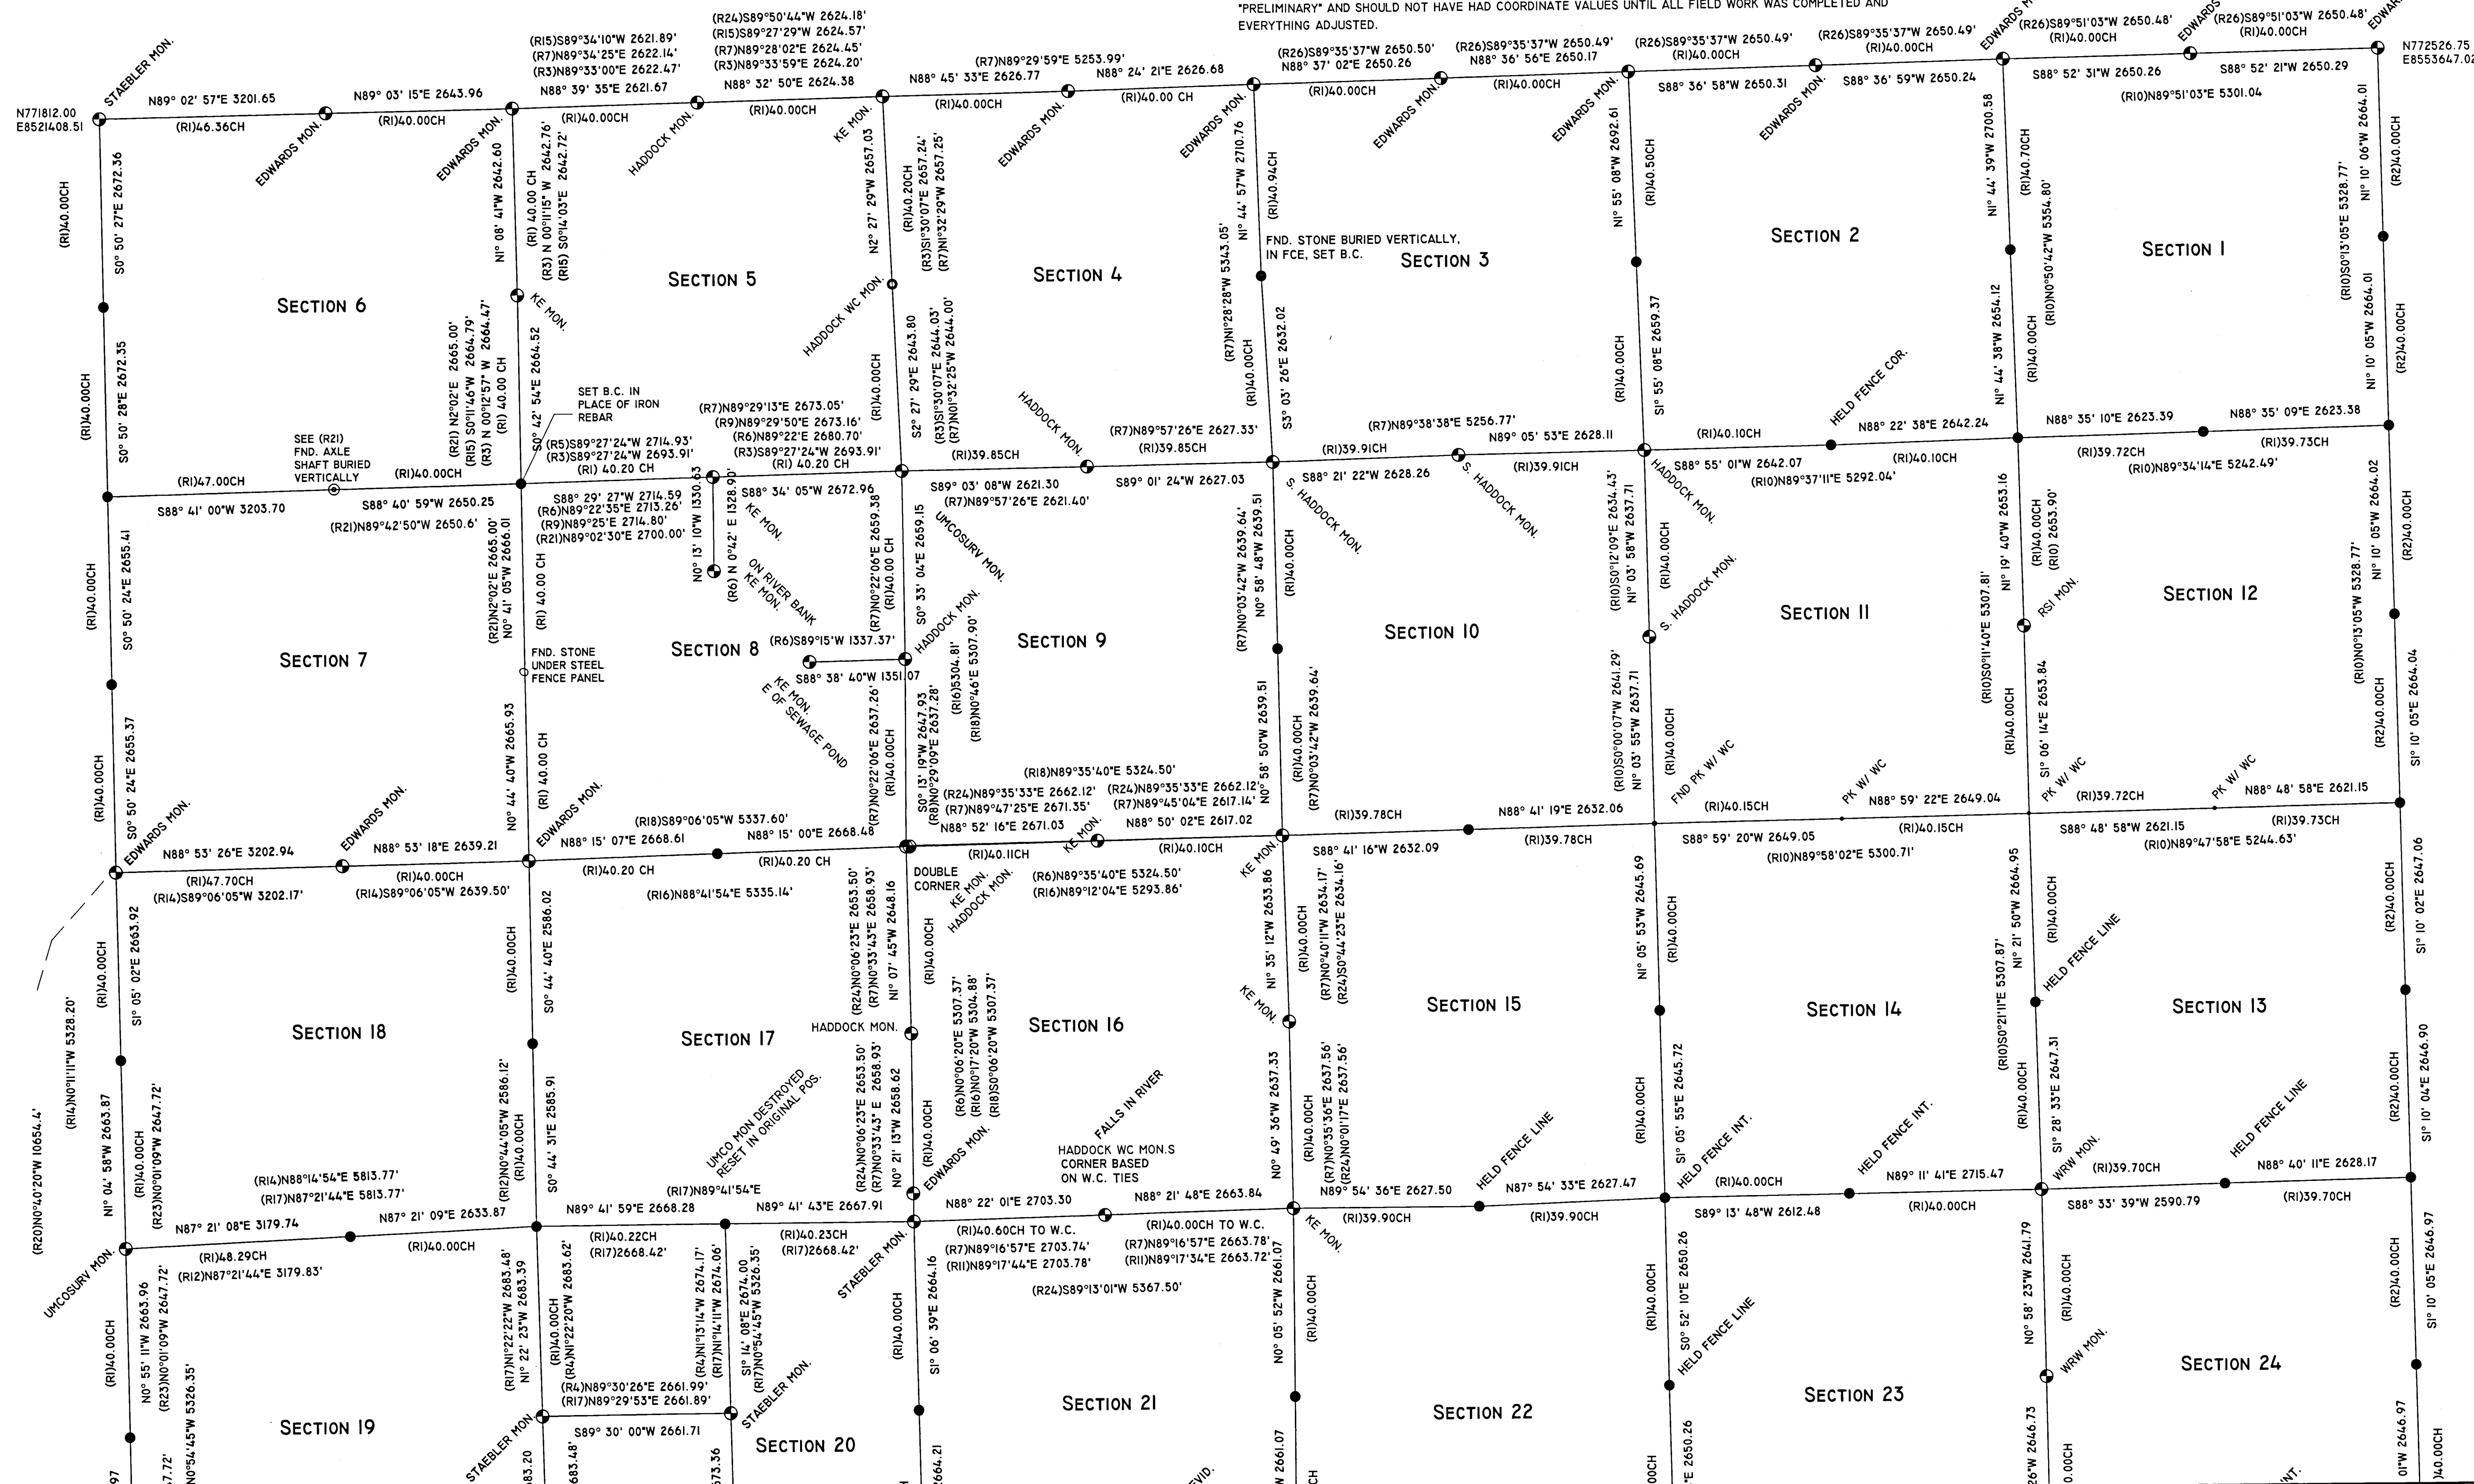
IT WAS BROUGHT TO MY ATTENTION THAT I HAD SOME LINE-WORK ISSUES ON COUNTY SURVEY II-38-C. I FOUND THAT MY AUTOCAD SOFTWARE HAD ISSUES CLIPPING TO THE ACTUAL SURVEY NODES ON THE DRAWING IN SEVERAL PLACES. THIS CORRECTIVE PLAT FIXES FOUND ERRORS IN BEARING AND DISTANCE CALLS. THE 1/4 CORNER COMMON TO SECTIONS 18 AND 19 WAS ERRONEOUSLY PROPORTIONED BY 1.0 FOOT, AND THE COORDINATES TO THE 1/4 CORNER COMMON TO SECTIONS 25 AND 36 WAS INCORRECTLY REPORTED. BECAUSE OF SAID ERRORS I COMPLETELY REVIEW ALL LINE-WORK AND LAND CORNER RECORDS TO INSURE THAT THERE WAS NOTHING ELSE THAT WAS MISSED. AN AFFIDAVIT OF CORRECTION IS FILED SEPARATELY ADDRESSING EACH INDIVIDUAL ISSUE. AFTER MEETING WITH DAVID H. KRUMBEIN, UMATILLA COUNTY SURVEYOR, ON SEPTEMBER 27, 2017, HE SUGGESTED I FILE THIS CORRECTIVE PLAT TO ADDRESS SAID ERRORS, AND FILE AFFIDAVITS CALLING OUT THE CORRECT FILED LAND CORNER RECORDS AND LIST ANY CORRECTIONS MADE. FOR THE RECORD, ONLY LAND CORNER RECORDS THAT ARE REFERENCED TO I2-094-C OR ARE LISTED WITH XXX-II-XXX HAVE THE CORRECT NAD83 ORNSPC COORDINATES. DUE TO THE LENGTH OF TIME NEEDED TO COMPLETE THIS CONTRACT, IN ACTIVE FARM GROUND, I FELT COMPELLED TO FILE WHAT SHOULD HAVE BEEN LABELED 'PRELIMINARY' AND SHOULD NOT HAVE HAD COORDINATE VALUES UNTIL ALL FIELD WORK WAS COMPLETED AND EVERYTHING ADJUSTED.

It has come to my attention that I had a CAD issue, and some of the line work on this map of survey
exhibits the wrong bearing and distances due to lines not snapping correctly to the data nodes.
Corrections, as noted and read from left to right on the map of survey, to wit:
