OREGON CORNER RESTORATION FORM

Section 2 Township 1S Range 34E
 County Umatilla Date: Dec 22, 1997

Corner Designation: 1S34A19

North 1/4 corner to section 2
 T1S, R34E, W.M.

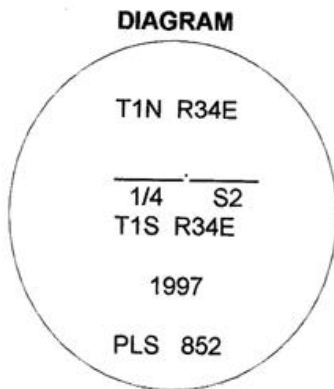
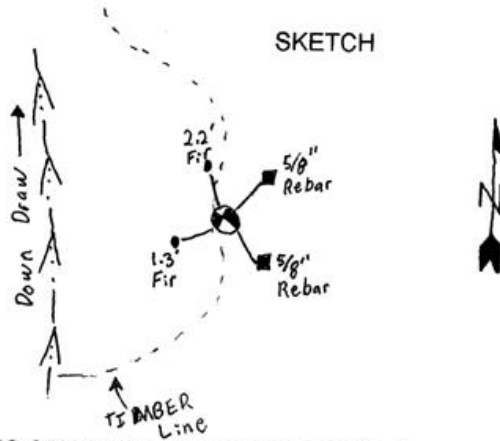
Set a 2 1/2" Brass cap on a 1 1/4"x30" galvanized iron pipe 27" in the ground on the east side of a steep draw at the edge of the timber stamped as shown in the diagram above.

For references, I set two 5/8" by 24" rebars with 1.25" red plastic caps stamped ORLS 852 and WALS 13922 as described below:

- a rebar bears N46°E, 25.1 feet;
- a rebar bears S21°E, 27.9 feet;

ALSO: Bearing trees with attached 1 1/8" brass washer stamped ORLS 852 and WALS 13922
 A 2.2' DBH Douglas fir bears N4°W, 37.2 feet;
 A 1.3' DBH Douglas fir bears S86°W, 26.9 feet;

The monument was set by a closed loop traverse using a Geodimeter System 600 Electronic Total Station. References were set and located using a compass and steel chain.
