**KRUMBEIN ENGINEERING LTD.**  
ENGINEERS - SURVEYORS - PLANNERS  
361 S.E. Second Pendleton, Oregon

Survey for

**CALDWELL - BANKER**

Lot 3, Blk 1, Orange & Cowboys Add.  
Pilot Rock, Oregon

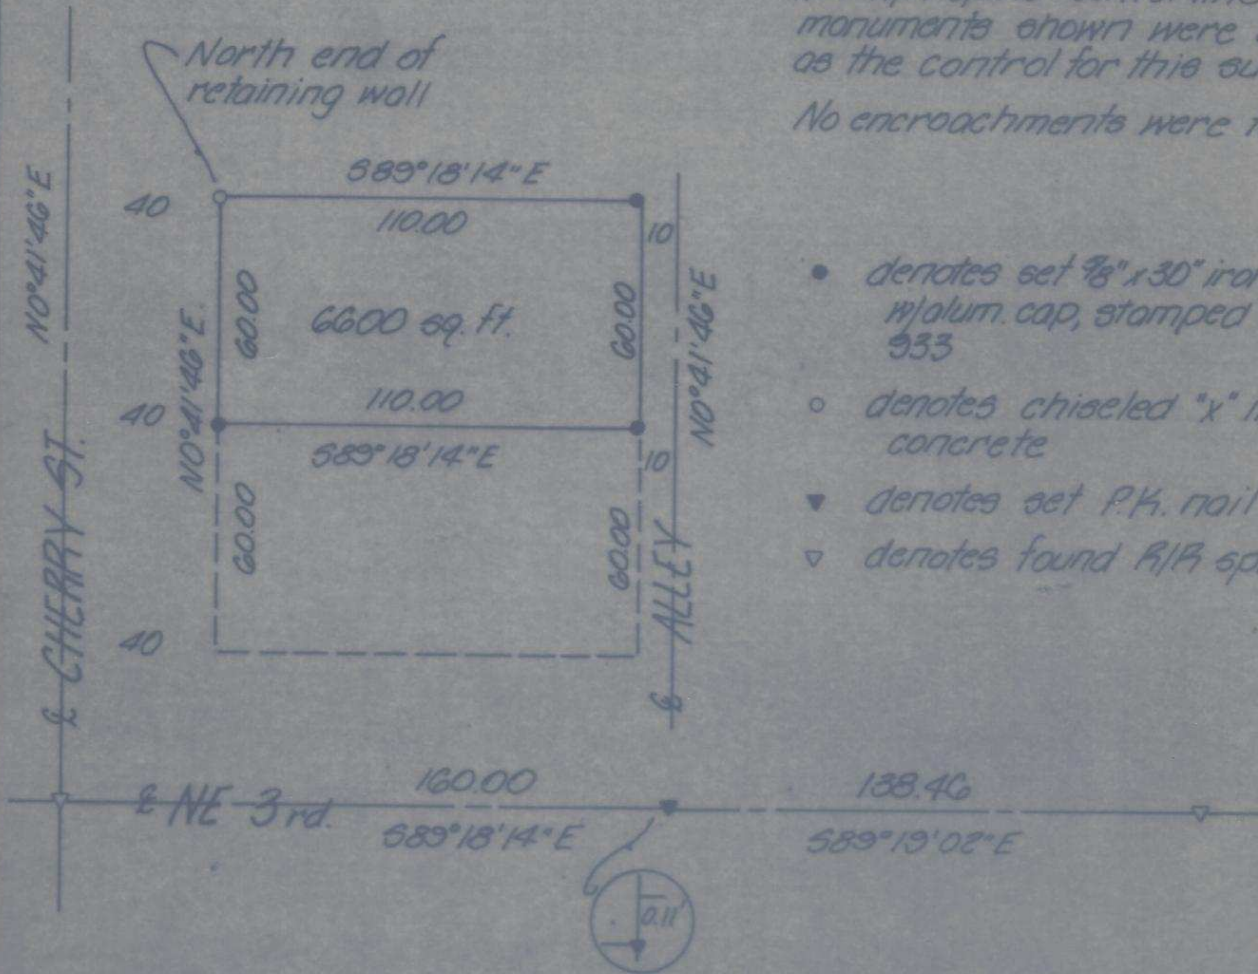
Bearings and distances are based on the Pilot Rock St. monumentation, survey by Wallulis and Ass., dated Feb. 16, 1979, County Surveyors Drwg. No. G-924-B.

The R/R spike centerline monuments shown were used as the control for this survey.  
No encroachments were found.
