NARRATIVE OF SURVEY

THIS SURVEY WAS PERFORMED AT THE REQUEST OF ENGINEERING NORTHWEST, LLC. THE PURPOSE OF THE SURVEY WAS TO LOCATE AND MONUMENT THE BOUNDARY OF THE LANDS OF DENNIS E. AND CONNIE R. BURKE DESCRIBED IN THE SPECIAL WARRANTY DEED RECORDED IN UMATILLA COUNTY MICROFILM REEL 801, PAGE 78 AND TO PROVIDE TOPOGRAPHIC INFORMATION FOR USE IN PROJECT PLANNING OF FUTURE DEVELOPMENT OF THE BURKE PROPERTIES AS SHOWN HEREON.

Project No. 22-11 SCALE: 1" = 40'

WITNESS TREE SURVEYING

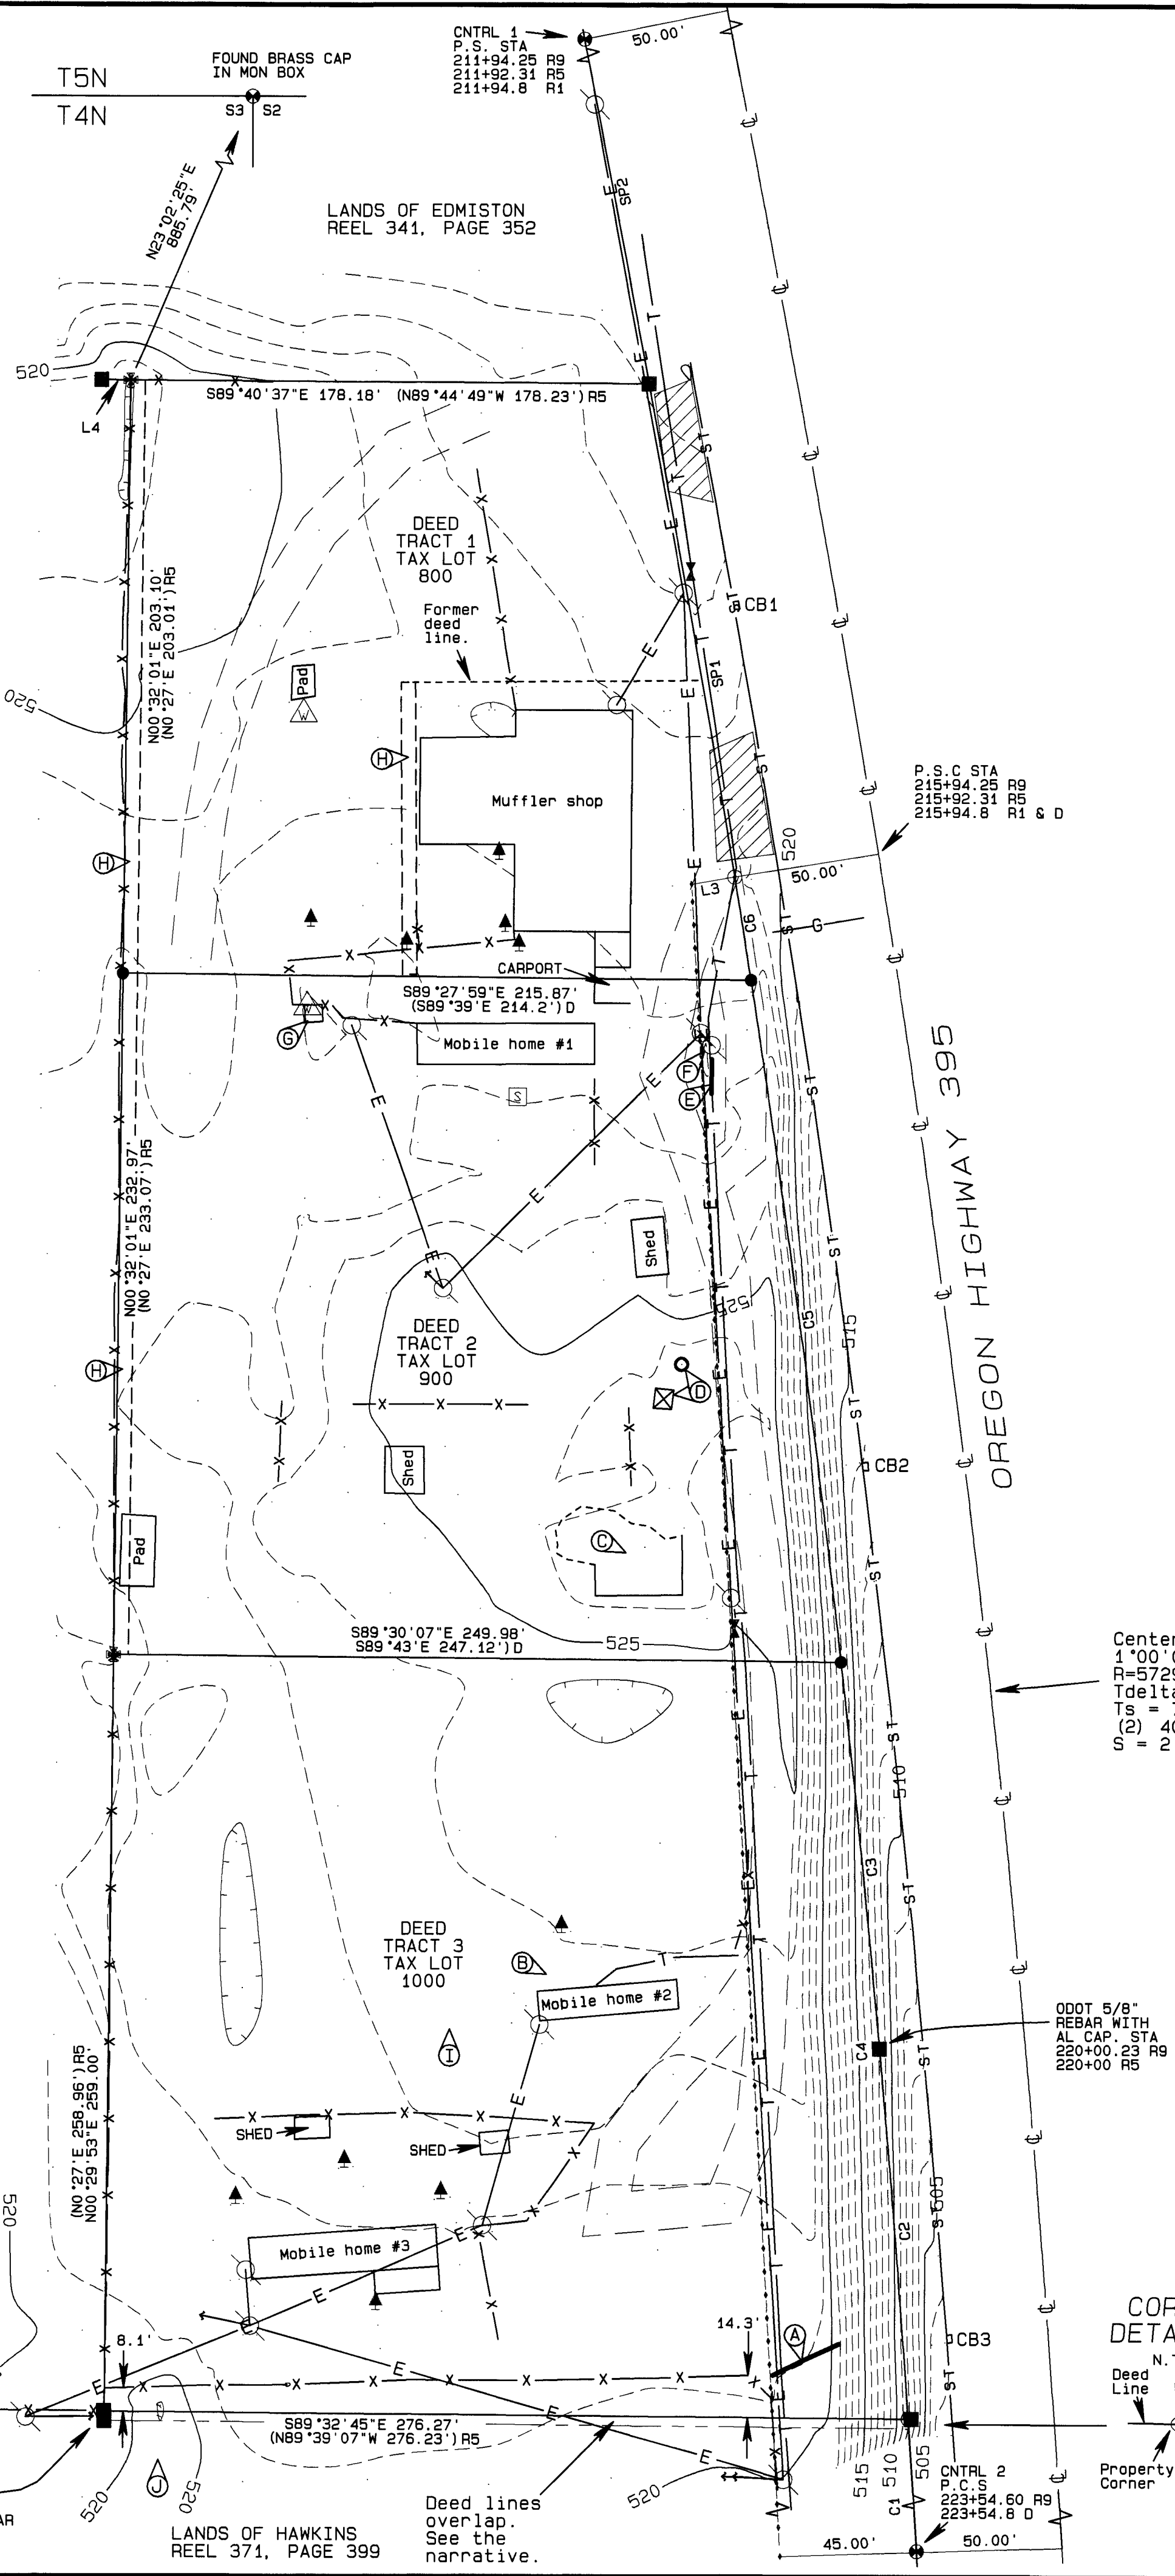
THE EASTERLY BOUNDARY OF THESE THREE TRACTS ARE ALL DESCRIBED AS RUNNING ALONG THE WESTERLY HIGHWAY RIGHT OF WAY LINE. THERE HAVE BEEN SEVERAL SURVEYS ALONG THIS ROUTE, BY ODOT AND OTHERS, EACH WITH SLIGHTLY DIFFERENT STATIONING. THIS ISSUE WAS SPECIFICALLY ADDRESSED IN ODOT SURVEY 17-012-B. TO ESTABLISH THE HIGHWAY RIGHT OF WAY I HELD THE RECORD CENTERLINE CURVE DATA PROVIDED ON ODOT SURVEY 17-012-B AND HELD THE FOUND ODOT MONUMENTS AS SHOWN ON THIS MAP.

THE DESCRIPTION FOR EACH OF THE THREE TRACTS CONTAIN CALLS FOR IRON MONUMENTS AT THE CORNERS. THE DATA CITED IN THESE DESCRIPTIONS ARE THE SAME AS THE DATA SHOWN ON SURVEYS Q-576-AX AND Q-584-AX BY VERL FRALEY, MR. FRALEY'S SURVEYS ARE NOT DATED SO IT IS IMPOSSIBLE TO CONFIRM WHETHER THE MONUMENTS CALLED FOR IN THE DEEDS ARE THOSE SET BY FRALEY. SURVEY 97-249-B REFERENCES THE FRALEY SURVEYS BUT CALLS THE FOUND MONUMENTS OF UNKNOWN ORIGIN EVEN THOUGH HOLDING THEM AS THE MONUMENTS CALLED FOR IN THE DEEDS. I CONCUR THAT THE FOUND MONUMENTS ARE IN FACT THOSE CALLED FOR IN THE DEEDS AND HAVE THEREFORE HELD THEM AS CONTROLLING FOR THIS SURVEY.

THE DESCRIPTION FOR TRACT 3 CALLS FOR RUNNING ALONG THE SOUTH LINE OF THE NE1/4 OF THE NE1/4. THAT LINE AS DETERMINED BY THE FOUND IRON MONUMENTS OVERLAPS THE TRUE 1/16TH LINE BY 3' MORE OR LESS. IT APPEARS THAT THIS OVERLAP IS DUE TO THE FACT THAT THE LEGAL DESCRIPTIONS ALSO INDICATE THAT ALL THREE TRACTS ARE LAID OUT AT RIGHT ANGLES TO THE SECTION LINE AS OPPOSED TO FOLLOWING A CORRECT SUBDIVISION OF THE SECTION. THIS OVERLAP IS NOTED IN BOTH SURVEYS 97-249-B AND 00-046-B. I HAVE HELD THE TRUE 1/16TH LINE AS DID SURVEYS 97-249-B AND 00-046-B.

THE MONUMENT FROM SURVEY 00-046-B NEAR THE SOUTHEAST CORNER OF TRACT 3 WAS SET ON A HIGHWAY RIGHT OF WAY LINE THAT WAS DETERMINED BY THE DEED RATHER THAN BY THE ODOT MONUMENTS ALONG THIS LINE. THIS MONUMENT FALLS ABOUT 1 FOOT EASTERLY OF THE RIGHT OF WAY LINE AS MONUMENTED. I HELD THIS MONUMENT TO REPRESENT THE TRUE 1/16TH SECTION LINE BUT NOT THE RIGHT OF WAY LINE.

- (A) BARRICADE MADE OUT OF 6" PIPE CONCRETE FILLED BOLLARDS AND STEEL GUARD RAIL.
(B) HISTORIC AERIAL IMAGERY INDICATES A POTENTIAL OF SIX DRAIN FIELDS. ONLY TWO CLEANOUTS WERE FOUND. CONFIRMATION OF ADDITIONAL DRAIN FIELD STRUCTURES BEYOND THOSE SHOWN HEREON IS BEYOND THE SCOPE OF THIS SURVEY.

(C) BURNED OUT REMAINS OF PRIOR BUILDING. A SMALL STREAM OF WATER RUNNING OFF THE SLAB INDICATES WATER SUPPLY TO THE BUILDING IS STILL ACTIVE.
(D) THIS SMALL SHED CONTAINS A PRESSURE TANK AND ELECTRICAL COMPONENTS FOR A PUMP. THE SOURCE OF THE POWER IS UNKNOWN. THE VALVE BOX, WHICH CONSISTS OF A 50" PIPE BURIED ON END, CONTAINS PIPING. THE EXTENT OF THE WATER SYSTEM IS UNKNOWN.

(F) THIS POWER POLE CONTAINS A METER BASE AND CONDUIT DROP TO AN UNDERGROUND POWER LINE. THE DESTINATION OF THE UNDERGROUND POWER IS UNKNOWN.
(G) THE ASSOCIATED PRESSURE TANKS FOR THIS WELL SIT EXPOSED ABOVE GROUND ON A CONCRETE SLAB. CONNECTIONS INDICATE SERVICE TO THREE TEMPORARY STRUCTURES. HOWEVER, THE EXTENT OF THE SYSTEM IS UNKNOWN.

(I) TAX LOT 1000 WAS FORMERLY THE SITE OF THREE MOBILE HOMES. THE EXISTENCE AND / OR EXTENT OF A DOMESTIC WATER SUPPLY SYSTEM IS UNKNOWN.
(J) REMAINS OF AN IRRIGATION DITCH MAY BE SEEN WESTERLY AND SOUTHERLY OF THE SW CORNER OF TAX LOT 1000 BUT NO OTHER INDICATIONS OF IRRIGATION DITCHES WERE FOUND.

6" x 6" rebar from survey 97-249-B in concrete at base of fence corner post. The fence has been disturbed.
CORNER DETAIL 1
N.T.S.

CORNER DETAIL 2
N.T.S.

Calculated record position based on survey 97-249-B.
FOUND 1/2" IRON REBAR SEE DEED AND (R5)

Deed lines overlap. See the narrative.
