OREGON CORNER RESTORATION FORM

Section 15 Township 3N Range 27E
 County Umatilla Date: 07-20-02
 Corner Designation: 3N27J43

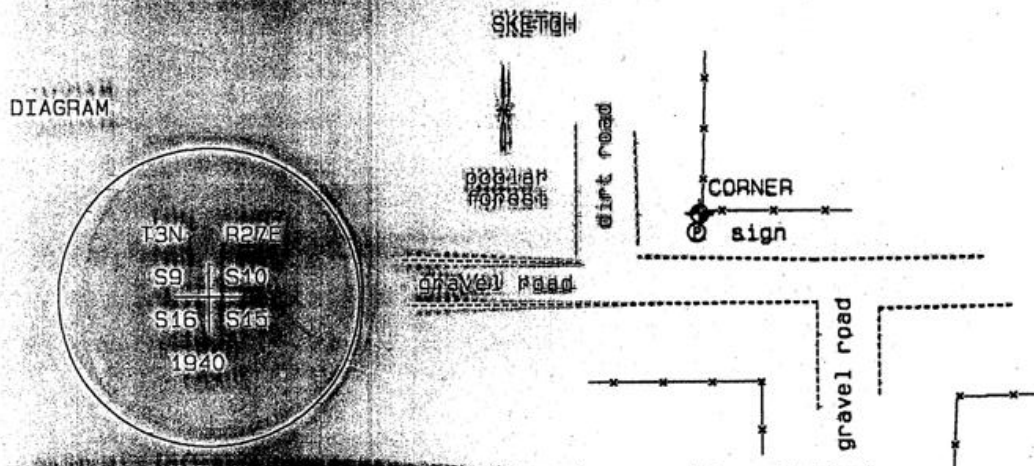
Previous Renewals / Surveys, etc.
 Survey 90-49-B found a 1940 GI-0 brass cap here.

Found the above brass cap in good condition.
