# OREGON CORNER RESTORATION FORM

Section 14 Township 3N Range 27E  
 County Umatilla Date 06-28-08

Corner Designation: 3N27J24  
 Condition Report Only  
 Not Found  
 Remonumented  
 Unrecorded  
 Surveyed In  
 Referenced Out

Section 14 Township 3N Range 27E  
 County Umatilla Date 06-30-02

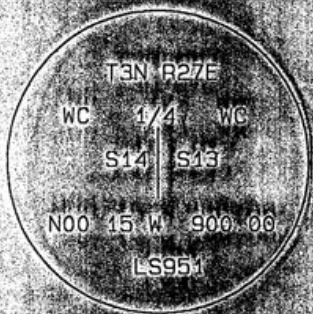
SKETCH

Found the record monument in good condition. Computed the coordinates for the true corner based on ties to this witness corner and the north 1/16 corner also set by survey 99-49-B.

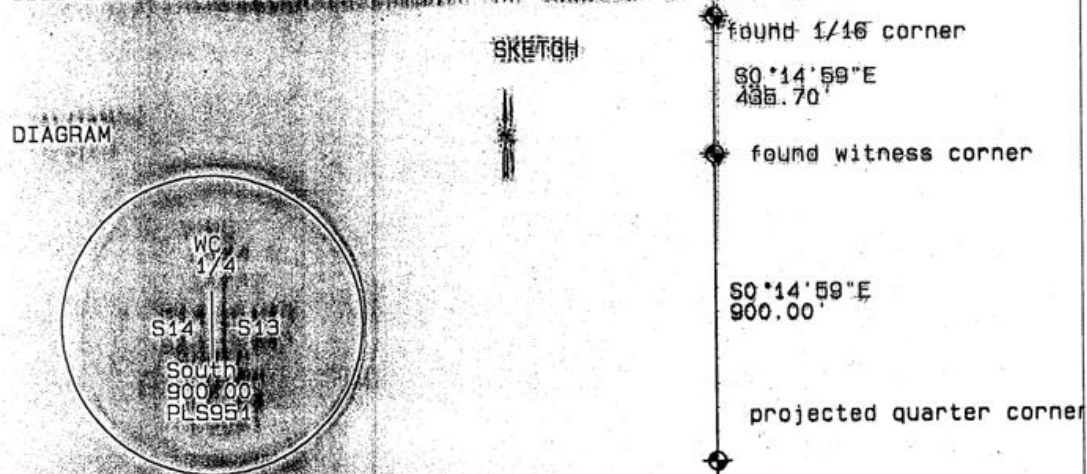
Found the north 1/16 and witness brass caps from survey 90-49-B. Used this information to compute the location of this corner.
