**OREGON CORNER RESTORATION FORM**

Section 1 Township 3N Range 28E  
 County Umatilla Date: 06-14-02

Corner Designation: 3N28A23

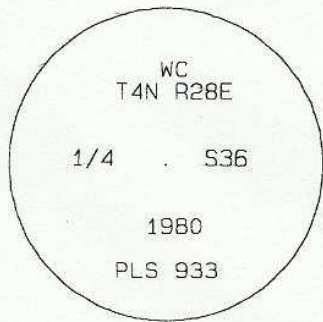
DIAGRAM

Found a witness corner stamped as shown in the diagram.

RR tie  
 N1°47'W,  
 52.8'  
 RR tie  
 N15°03'W  
 46.8'

RR tie  
 N23°37'E  
 57.3'

Note:  
 Bearings  
 and distances  
 are to east  
 witness corner.
