CORNER RESTORATION FORM

Township 3N Range 30E Section 9,10,15&16 County UMATILLA

State OREGON Date 4-8-2015 Number J-13

Corner Designation : SECTION 9, 10, 15 & 16

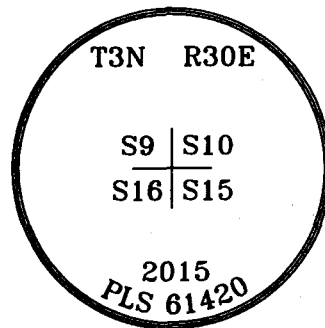
MONUMENT DETAIL

- SET 2 1/2" BRASS CAP ON 1 1/4"x30" PIPE AT GRADE 3'± EAST OF EDGE OF ROAD.
- SET 5/8" REBAR & CAP PLS 61420 AT GRADE SOUTH SIDE OF POWER POLE SET BEARING OBJECT SIGN ON POWER POLE, N4°10'E 66.69'.
- SET 5/8" REBAR & CAP PLS 61420 AT GRADE BEARING OBJECT SIGN ON WOOD POST, N89°40'E 10.02'.
- SET 5/8" REBAR & CAP PLS 61420 0.5' BELOW GRADE ON EDGE OF BANK, S43°29'W 23.98'.
- SET 5/8" REBAR & CAP PLS 61420 0.3' BELOW GRADE ON EDGE OF BANK, N41°10'W 25.76'.
