ORIG **N PUBLIC LAND CORNER REPORT / RESTORATION REPC**  
 Umatilla County Surveyor's Office

<b>SECTION</b> 17 and 18	<b>TOWNSHIP</b> 3N	<b>RANGE</b> 36E
<b>COUNTY:</b> Umatilla		<b>DATE</b> 6/20/08
<b>CORNER DESIGNATION: M-5</b>  South 1/16 corner common to sections 17 and 18		<b>(Please check one)</b>
		<input checked="" type="checkbox"/> Condition Report Only
		<input type="checkbox"/> Not Found
		<input type="checkbox"/> Renewed
		<input type="checkbox"/> Unrecorded
		<input type="checkbox"/> Surveyed In
		<input type="checkbox"/> Referenced Out
Previous Renewals / Surveys, etc.  U.S. Indian Services Surveyor C.E. Redfield, set an Iron Post in 1919		
<b>Monument(s) &amp; Accessories Found: (Condition &amp; Source)</b>  Found a 2" galvanized Iron Pipe with a 2 1/2" Brass Cap in good condition, protruding 12" from the ground in an East-West fence line, 6 feet East of a 6" metal gate post.		
<b>Monument Detail:</b>

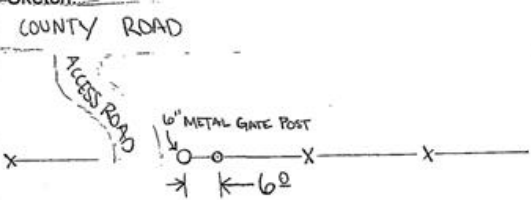
<b>Sketch:</b>

<b>New Accessories:</b>		
<b>Location &amp; Comments:</b>  Corner is located in an open flat on an East-West fence line, 6 feet East of a 6" metal gate post in a road entering from the County Road from the North. The corner is 230 feet South of the County Road		<b>Compass Declination:</b>
<b>Firm / Agency</b> USKH Address: 5 N. Colville St., Walla Walla, Wa 99632		<b>SURVEYOR'S SEAL</b>
