CORNER RECORD (SEARCH)

T 3S R. 33E

N.F. Umatilla State Oregon

Cor. No. E-9

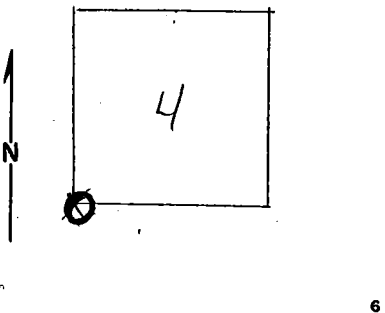
CORNER DIAGRAM

DESCRIBE CORNER MONUMENT FOUND *Original notes*
 BT PP 32" DBH N11W 24' sec. 50
 PP 19" DBH S42E 38' " 9
 DPP 42" " S28W 30' sec. 8 (fallen over)

DESCRIBE BEARING TREES OR OTHER OFFICIAL ACCESSORIES FOUND ²
 a section line board on Bear Wallow Rd. thus south 562' to a pile of rock to indicate the corner.
