OREGON CORNER RESTORATION FORM

Section 23 Township 4N Range 30E

R-17
(SOUTHWEST CORNER)

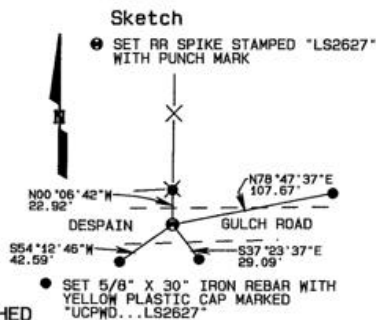
Monument Detail

AT THE INTERSECTION OF A NORTH-SOUTH FENCE LINE TO THE NORTH AND THE CENTER OF DESPAIN GULCH ROAD (FORMERLY ROAD NO. 199, ESTABLISHED ALONG THE SECTION LINE) SET A RAILROAD SPIKE STAMPED "LS2627" WITH PUNCH MARK FLUSH WITH PAVEMENT SURFACE.

- A 5/8" IRON REBAR WITH YELLOW PLASTIC CAP MARKED "UCPWD...LS2627 BEARS N00°06'42"W, 22.92';
- A 5/8" IRON REBAR WITH YELLOW PLASTIC CAP MARKED "UCPWD...LS2627 BEARS N78°47'37"E, 107.67';
- A 5/8" IRON REBAR WITH YELLOW PLASTIC CAP MARKED "UCPWD...LS2627 BEARS S54°12'46"W, 42.59';
- A 5/8" IRON REBAR WITH YELLOW PLASTIC CAP MARKED "UCPWD...LS2627 BEARS S37°23'37"E, 29.09'
