CORNERS OF THE PUBLIC SURVEY

T. 34 N R. 37 E W. Mer.

Sec. Corner common to Sections
2, 3, 34, and 35

CORNER RECORD (SEARCH)

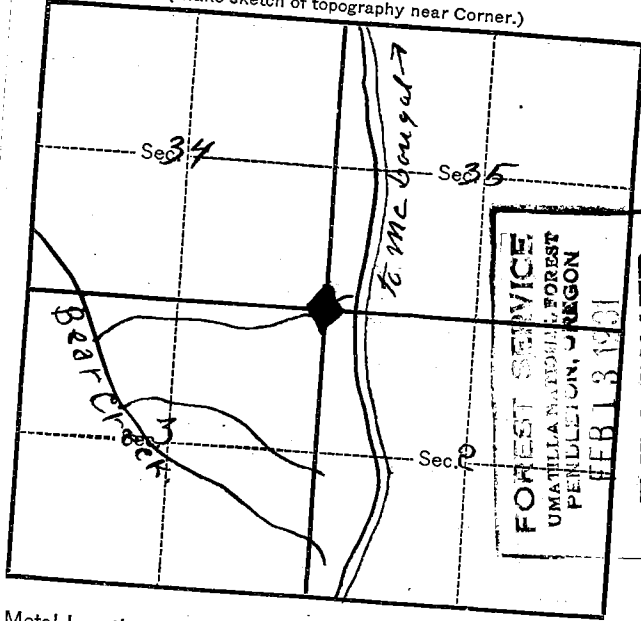
(Make sketch of topography near Corner.)

Metal Location Poster is on a W.F.
 tree 10 inches diameter, on the S
 side of Corner
 from which this Corner bears N. 10° W.
1/3 chains distant.

Corner is in bottom of a small
canyon which is a branch of
Bear Creek. Slope 30%, medium
stand of timber, both mature and
reprod. Open bunchgrass ridge
5 ch. south.

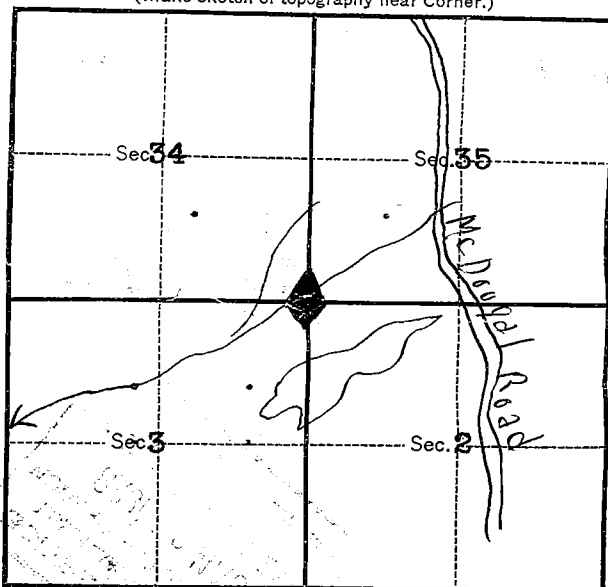
(Make sketch of topography near Corner.)

Large opening 5 chains south of
corner. Corner in bottom of small
draw leading into Bear Creek.

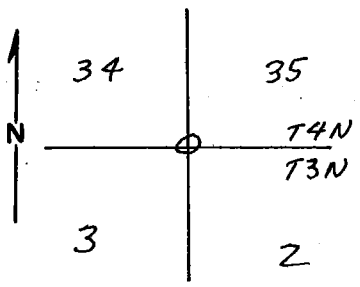
CORNER DIAGRAM

$2\frac{1}{2}$ " I. PINE W/ $3\frac{1}{2}$ " BLM BR. CAP, MKD →
5" ABOVE GROUND, GOOD CONDITION

OPT, 27" FIR, ON GROUND, ROTTED FACE, AND ROOT HOLE, BEARS N40°W, 35.0 FT.
OPT, 31" FIR SNAG, NO MARKS VISIBLE ON OPEN BLAZE, BEARS S40°W, 19.5 FT.
20" SPRUCE, SCRIBES "T3N R 37E S3BT" VISIBLE ON OPEN FACE, BEARS S51½°W, 12.5 FT.
10" SPRUCE, SCRIBES "T4N R37E S34BT" VISIBLE ON OPEN FACE, BEARS N18½°W, 42.0 FT.
16" SPRUCE, PITCHED OVER FACE, BEARS N17¾°E, 36.4 FT.
16" SPRUCE, PITCHED OVER FACE, BEARS S33¾°E, 18.8 FT.

CORNER LIES IN BOTTOM OF SHALLOW DRAW, ABOUT 700' W.
OF RD. 3715.

SET STEEL POSTS ABOUT 3' S. ~~WEST~~ OF CORNER, WITH SIGNS 54-2 AND 54-9
PAINTED A RED BAND AROUND BT'S.
