CORNER RECORD (SEARCH)

T. 4S R. 30E

**CORNER RECORD (SEARCH)**  
(Ref. FSM 7151.4)

Tract or Survey No. 4-144 Cor. No. J-23

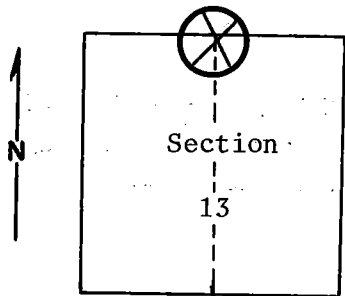
**CORNER DIAGRAM**

Material: Basalt stone. Size: 15" x 8" x 5".

6 inches above ground; fair condition. No markings visible. Stone sets in circle of smaller stones.

A 14-inch p.pine (double boled) bears east about 80 to 90 feet. It has a "Bureau of Land Management" aluminum location poster and a "Harris Pine" aluminum location poster on it.

There is an old east-west road along the ridge top approximately 200 feet south of  $\frac{1}{4}$  corner.

I placed a location poster on a scrubby 6-inch p.pine approximately 150 feet south of the stone mound (50 feet north of road).
