Index  
File No. A-23  
T 4S R. 31E  
Merid. Willamette

CORNER RECORD (SEARCH)

Tract or  
Survey No. 5-47 Cor. No. A-23

R.D. Ukiah County Umatilla  
N.F. Umatilla State Oregon

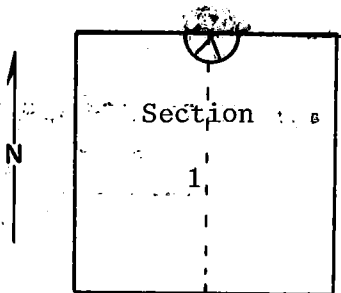
CORNER DIAGRAM

Markings: None.

A 30-inch p.pine stump (very rotten) blazed on NW face. "B.T." visible by opening blaze. There is evidence of an old east-west fence (old wire) through approximate location of  $\frac{1}{4}$  corner. B.T. stump will soon be gone.

B.T. stump is 400 or 500 feet, approximately south, from cabin. Cabin is at end of primitive road. See Carney Butte 7.5 minute quadrant map.

I stuck 2 blank B.T. tags (back to back) in top of rotten B.T. stump. I also placed 2 location posters on a 14-inch snag topped white fir which stands against the west edge of B.T. stump. (Posters are on east and west sides of tree.)
