OREGON CORNER RESTORATION FORM

SECTION 34 TOWNSHIP 5 NORTH RANGE 27 EAST
 COUNTY : UMATILLA DATE 5/06

S 1/4 SECTION 34 STANDARD CORNER

X CONDITION REPORT ONLY

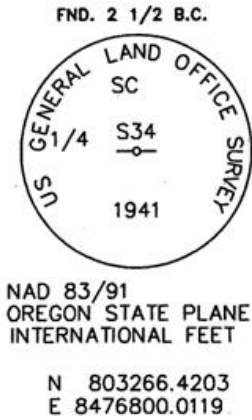
MONUMENT DETAIL

2 1/2" B.C. 1/4 CORNER STANDARD CORNER STAMPED 1941

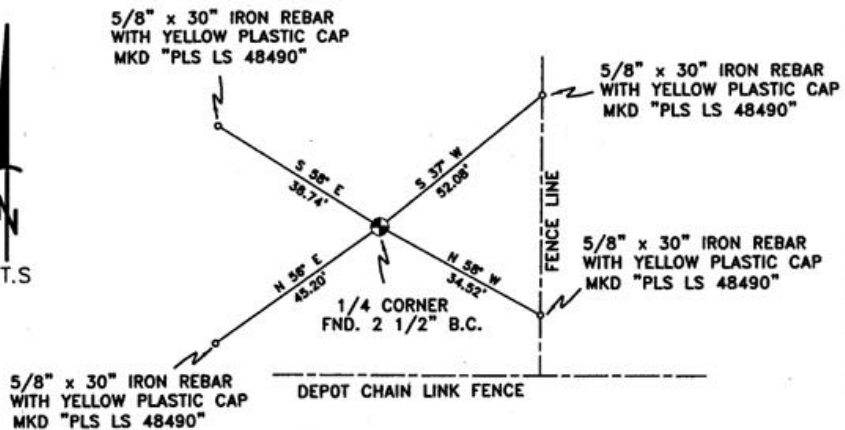
SKETCH

- A 5/8" x 30" IRON REBAR WITH A YELLOW PLASTIC CAP MKD "PLS LS 48490" LIES N 37° E, 52.08 FEET.
- A 5/8" x 30" IRON REBAR WITH A YELLOW PLASTIC CAP MKD "PLS LS 48490" LIES S 58° E, 34.52 FEET.
- A 5/8" x 30" IRON REBAR WITH A YELLOW PLASTIC CAP MKD "PLS LS 48490" LIES S 56° W, 45.20 FEET.
- A 5/8" x 30" IRON REBAR WITH A YELLOW PLASTIC CAP MKD "PLS LS 48490" LIES N 58° W, 38.74 FEET.
