OREGON CORNER RESTORATION FORM

SECTION 23, 26 TOWNSHIP 5 NORTH RANGE 29 EAST

CORNER DESIGNATION

1/4 CORNER

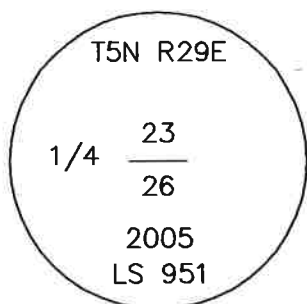
MONUMENT DETAIL

FOUND 2 3/8" BRASS CAP STAMPED AS BELOW.
FOUND 5/8" IRON ROD WITH PLASTIC CAP STAMPED LS 951 BEARS S 05°14'12" W, 226.54'.
