CORNER RECORD (SEARCH)

T 5S R. 32E

R.D. UKIAH County UMATILLA

N.F. UMATILLA State OREGON

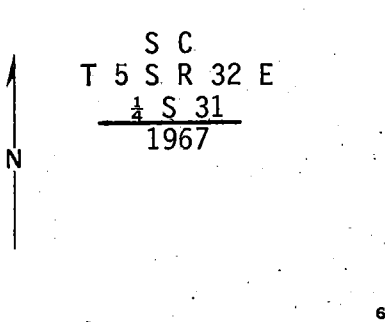
CORNER DIAGRAM

Found an iron pipe, firmly set, 2½ ins. diam., in a mound of stone, 3 ft. base, to top, with brass cap mkd.

U.S. Dept. of Interior  
Bureau of Land Management

S C  
T 5 S R 32 E  
1/4 S 31  
1967

A Ponderosa Pine, 25 ins. diam., bears N. 27½°E., 85½ lks. dist., scribing visible on partially healed blaze.  
A Ponderosa Pine, 10 ins. diam., bears N. 35°W., 100½ lks. dist., scribing visible on partially healed blaze.

Corner of fences N-E-W is 24' East and 13' South.
