OREGON CORNER RESTORATION FORM

Section: 13 & 24
Township: 6 North
Range: 35 East of the Willamette Meridian
County: Umatilla
Date: June 1, 2002

This quarter corner is common to sections 13 & 24.

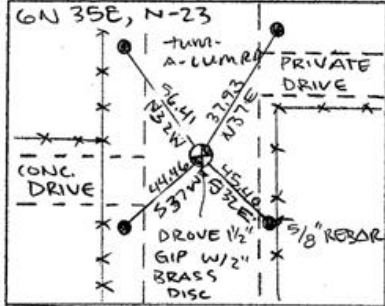
Monument Detail:

At the location of the found rock drove a 1 ½" x 15 ½" galvanized iron into roadbed. Placed 10" of concrete around pipe filled pipe with concrete and set 2" brass disc on the top of pipe ½" below the surface. Buried rock alongside.

T6N R35E
LS 2360
S13
S24
2001
