CORNER RECORD (SEARCH)

Index  
File No. C-1

T 6S R. 33E

Merid. WILLAMETTE

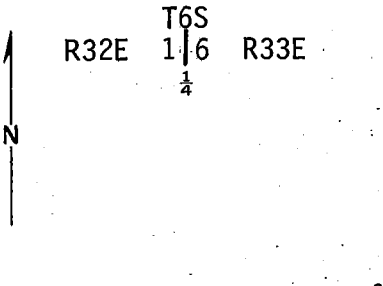
CORNER DIAGRAM

Found an iron pipe, firmly set,  
2½ ins. diam., in a mound of stone  
3 ft. base, to top, with brass cap  
mkd:

R32E T6S R33E  
S1 | 1/4 S6  
1968 2

- A Ponderosa Pine, 25 ins. diam., bears N 12°E 9 lks. dist., with healed blaze. (Record, 5 lks.)
- A Ponderosa Pine stump, 18 ins. diam., bears S 37°W 42 lks. dist., with scribe marks 1/4 S BT visible on open and weathered blaze. (Record S 44°W)
- A Ponderosa Pine snag, 11 ins. diam., bears S 31°W 89 lks. dist., marked 1/4 S1 BT.

A 14" Ponderosa Pine, scribed "1/4 S 1 BT" on a double blaze bears N 89°W 77.0 feet, with brass washer marked "LS 1099" attached to lower blaze.
