USDA-FOREST SERVICE

CORNER RECORD (SEARCH)

T 6S R. 33E. R.D. Ukiah County Umatilla

Merid. Willamette N.F. Umatilla State Oregon

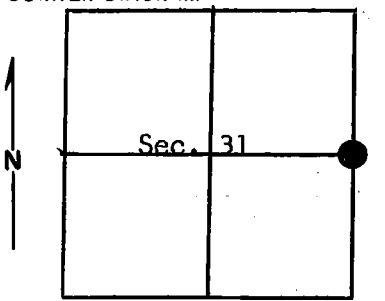
CORNER DIAGRAM

None

Found both trees.

A pine 26 in. diam. brs. S 73° W 26 lks.
A pine 28 in. diam. brs. S 79° E 11 lks. (N 79 E ?) (69)

Corner is about 600 ft. North of Camp Creek

Set 2½" x 30" iron pipe with brass cap (stamped)

Pipe is 23" in ground.

T.	6S	R	33E
		¼	
S	31		S 32
		1978	
		PLS 933

Set steel post 3 ft. West with signs 54-2 and 54-4.

Painted red band around BT trees.
