USDA-FOREST SERVICE

CORNER RECORD (SEARCH)

North Fork John Day

County Umatilla

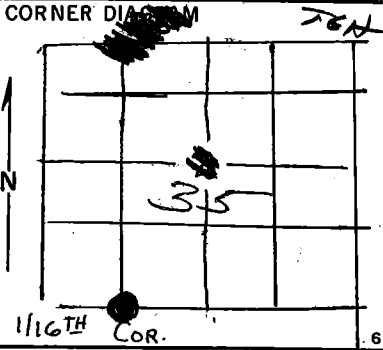
PHOTO IDENTIFICATION DATA
Photo No. EXR-78-4-233
Filed At. 2210 CENTRAL DESOL. C.H.
Object Ident. Photo Punched / I.D.
Ident. By 8-10-71
Signature _____

DESCRIBE CORNER MONUMENT FOUND
Brass Cap $3\frac{1}{4}$ dia. 5" high good condition
Markings - W 1/16 S 35 - 1968
Cadastral Survey S2 BLM *see mon. file T65, R32E*

DESCRIBE BEARING TREES OR OTHER OFFICIAL ACCESSORIES FOUND
Bearing Tree - 7" DBH - Blazed on NE side with 1/16 in blaze.
Tag 54-3 - S 57 W - 49 links to corner - T7S, R 32 E, Sec. 35 W
1/16 D.B. - 9-10-68 - Douglas Fir - Same tree - G.P. Tag -
T7S, R32E. - .06 ch. N 34 E - 1/16 cor. IP - Rs.

Range office
DESCRIBE CORNER LOCATION RELATIVE TO NEAR-BY FEATURES, ALSO HOW TO REACH CORNER
Bearing Tree - D. Fir blazed on S.E. side - Metal Tag 54-3
Corner is approx. N 38 E - 6 links. T7S, R32E, Sec.2
Corner W 1/16 D.B. 9-10-68
Bearing Tree - D. Fir - blazed on SW side - metal tag - G.P.
T6S R32E - JP - RS - 0.21 ch. S 30 W 1/16 corner
