CORNER RECORD (SEARCH)
(Ref. FSM 7151.4)

T. 7 S R. 32 E R.D. North Fork John Day County Grant

Merid. Willamette N.F. UMATILLA State Oregon

LAND CORNER RECORD
(Rectangular)

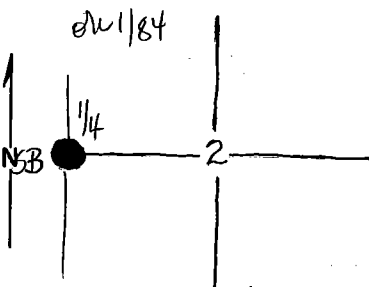
CORNER DIAGRAM

Brass Cap - $3\frac{1}{4}$ " dia. - 1" high, good condition.
Markings - $\frac{1}{4}$ C - sec 3 & 2 T7S, R32E (1967) BLM-Dept. Int. Cadastral Survey.

Bearing Tree - 6 feet west of haul road - 18" DBH Ponderosa Pine
G.P. metal tag - T7S, R32E. approx 2 ch. south to $\frac{1}{4}$ cor. L.L. - HBS.
Bearing Tree - White Fir 8" DBH - can be seen from haul road.
metal tag 54-3, N 46 E, Sec. 3 - JET 1967 - Blaze NE side ~~near~~
near ground. 8 1/2 lks. T. 7S, R. 32E.

Bearing Tree - Blaze NW side near ground. Metal tag 54-3. N $80\frac{1}{2}$ W
 $6\frac{1}{2}$ links. section 2, JET, 1967 12" Fir DBH, also Property Boundary
sign, metal, form 1505 easily seen from haul road.

Bearing log - Blaze NW side - Larch, approx. 30" DBH, Metal Tag
54-3 - Corner approx. 15 links N 35 W

Property Boundary Marker - Metal - form 1505 - W. Fir 4" DBH - Blazed on tree (two sides)
25 feet N.W. of Brass Cap. easily seen from road.

Ponderosa Pine - 18" DBH Branded *S* NE side. letter 18" high by 9" wide. approx. 30
feet NW of Brass Cap.
